Pier in Progreso, Mexico.
Inspection Report
Evaluation of the Stainless Steel Reinforcement
March 1999

Inspection Report

Evaluation of the Stainless Steel Reinforcement

March 1999

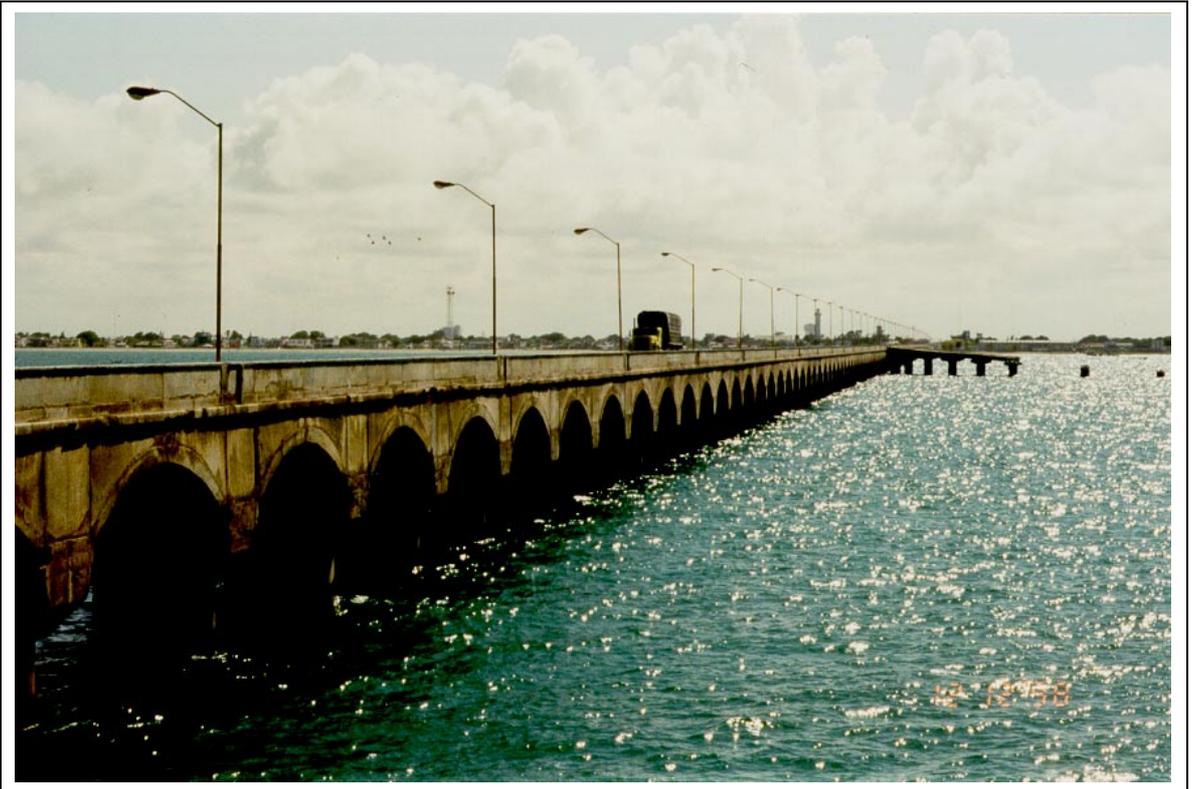
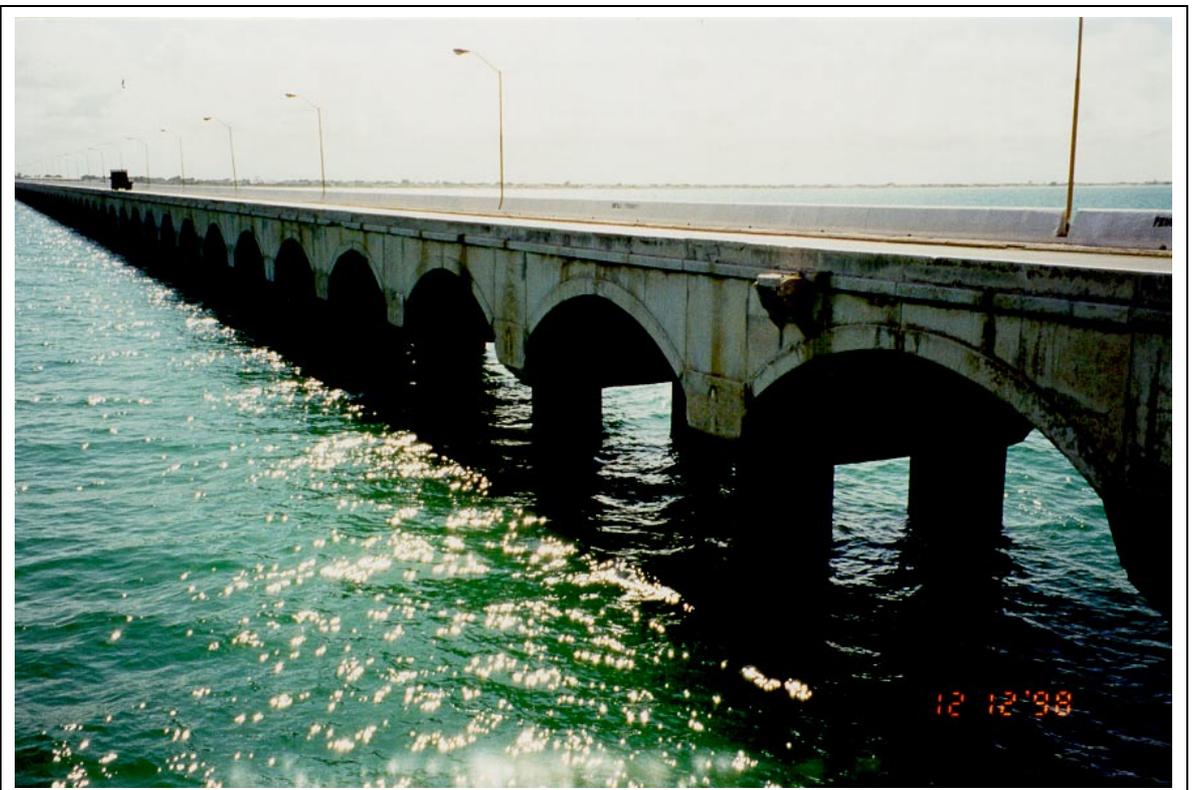
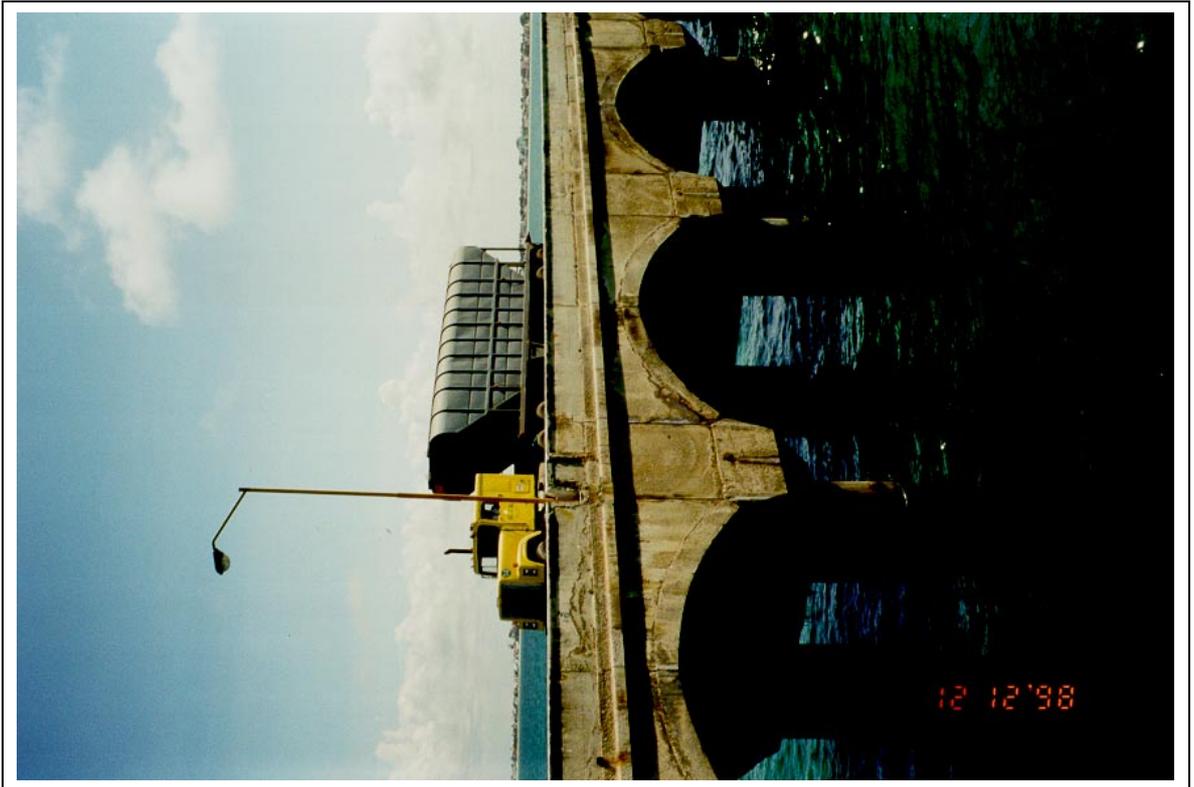
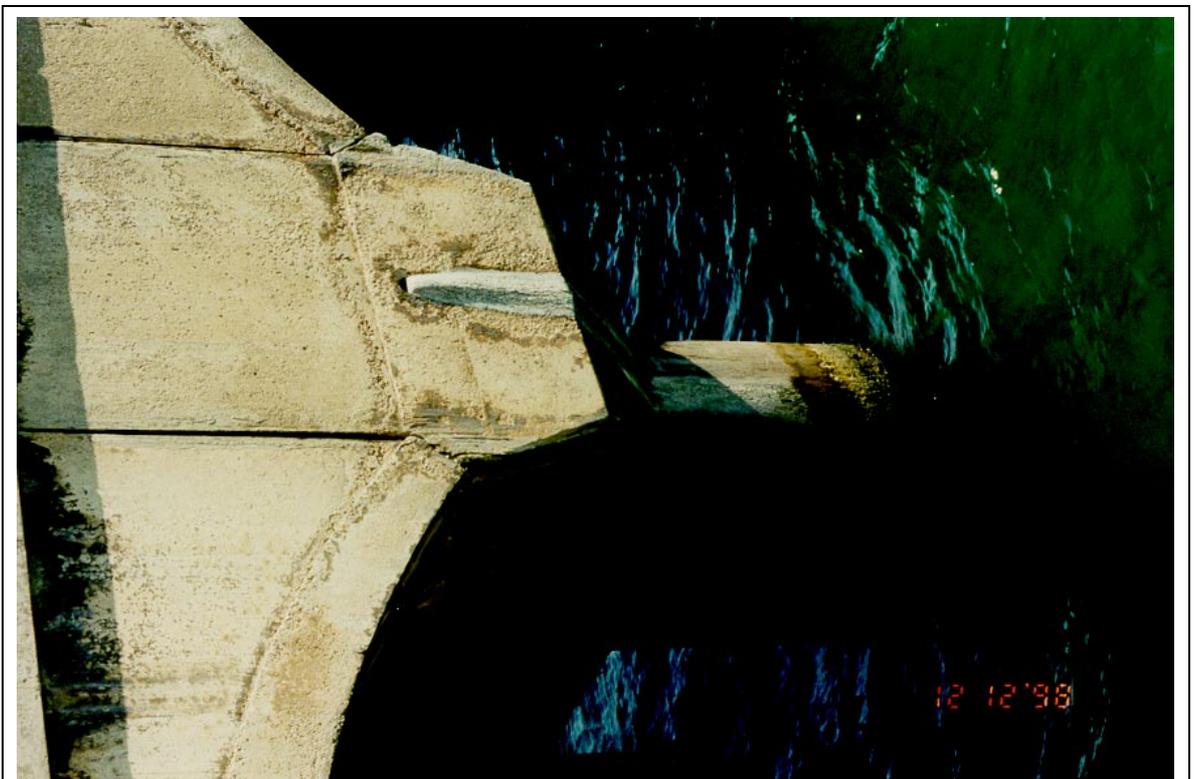
- The pier is generally in a good condition without any significant visible signs of deterioration or corrosion problems, see figures 1.3 to 1.6 in Appendix 1. However, in two specific locations on the west side of column no. 9 corroded reinforcement with no cover was visible (see the last bullet in this list). In general, no significant damage was observed except for casting defects such as honeycombing.

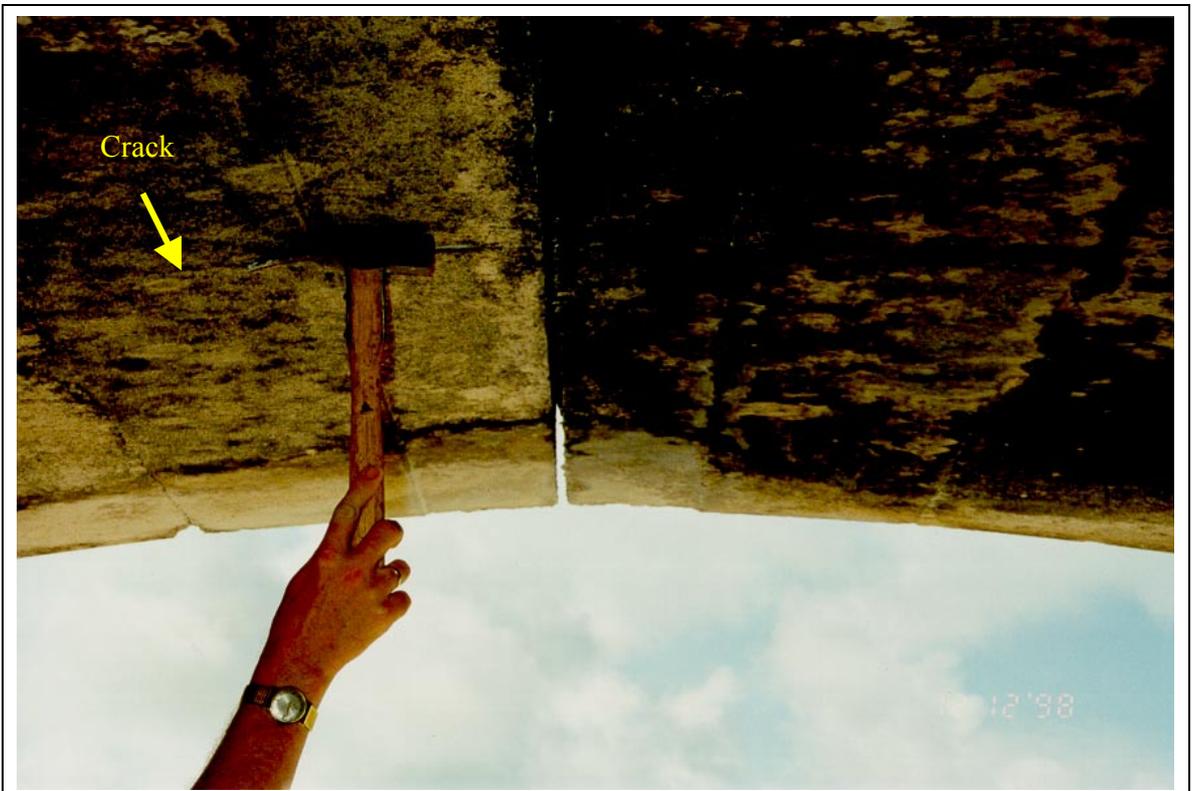
- There are a few fine longitudinal cracks (crack width less than 1 mm) in the soffit of the arches, see figures 1.8 and 1.11 in Appendix 1. No visible signs of corrosion were observed at the cracks.

Figure 1.8 Joint gab and longitudinal crack in the soffit of the arch at the mid of the span

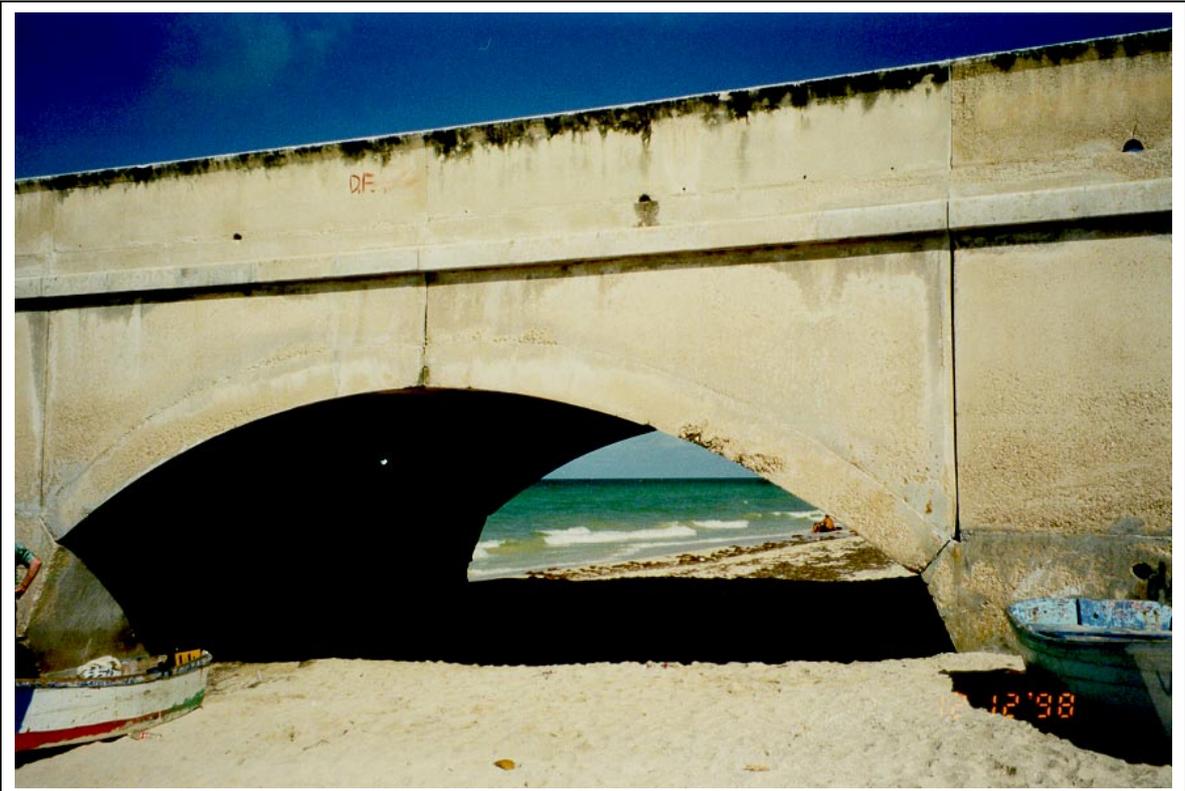
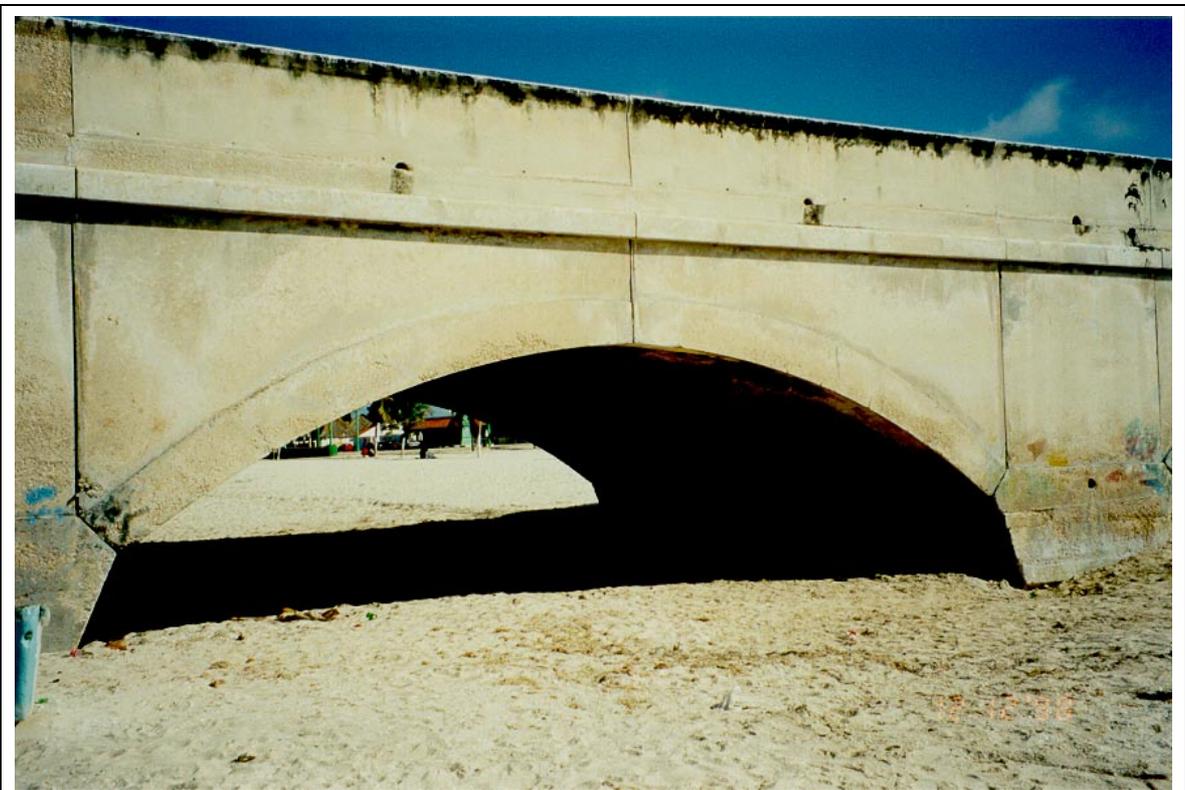
- The arches in span nos. 8 and 9 are generally in a good condition without any visible signs of corrosion problems, see figures 1.9 and 1.10 in Appendix 1.

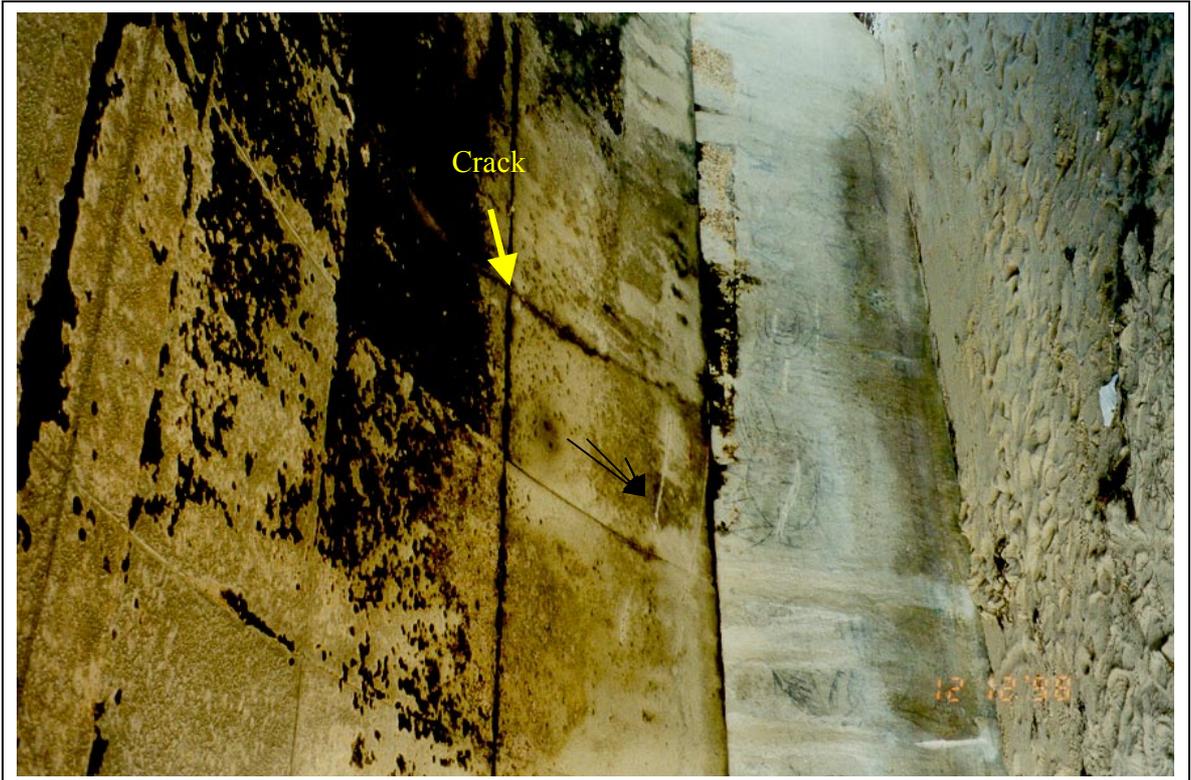
Figure 1.11 Longitudinal crack in the soffit of the arch

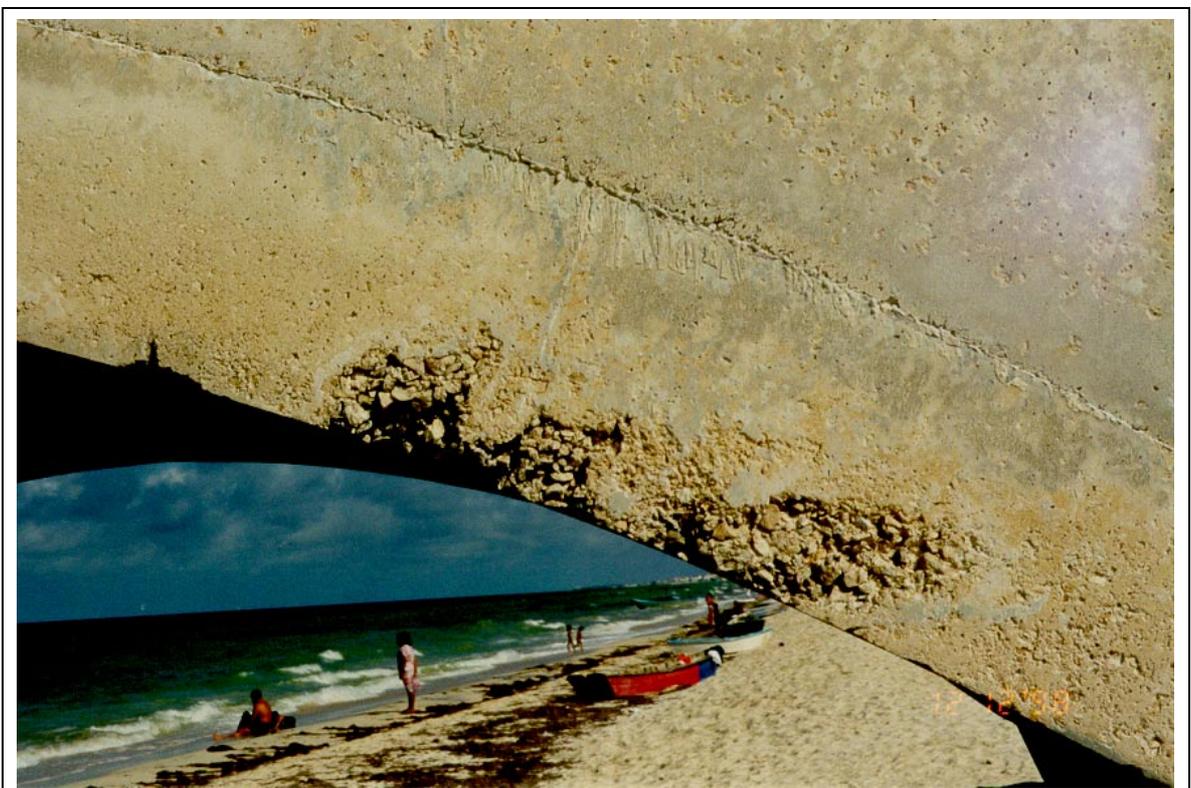
- Several honeycombs and other casting defects were located in the soffit and in the outer part of the arches as well as the visible part of the column, see figures 1.12 and 1.13 in Appendix 1. However, no visible signs of corrosion were observed at honeycombing and other casting defects.
- On the west side of column no. 9, reinforcement was visible in two locations. In both locations, the end of a hairpin stirrup was visible (no cover), see figures 1.14 to 1.16 in Appendix 1. In both locations, there was serious laminated corrosion on the visible reinforcement and the reinforcement area was reduced to approximately 60-70%.

Figure 1.12 Honeycomb at the edge of the arch in span no. 9

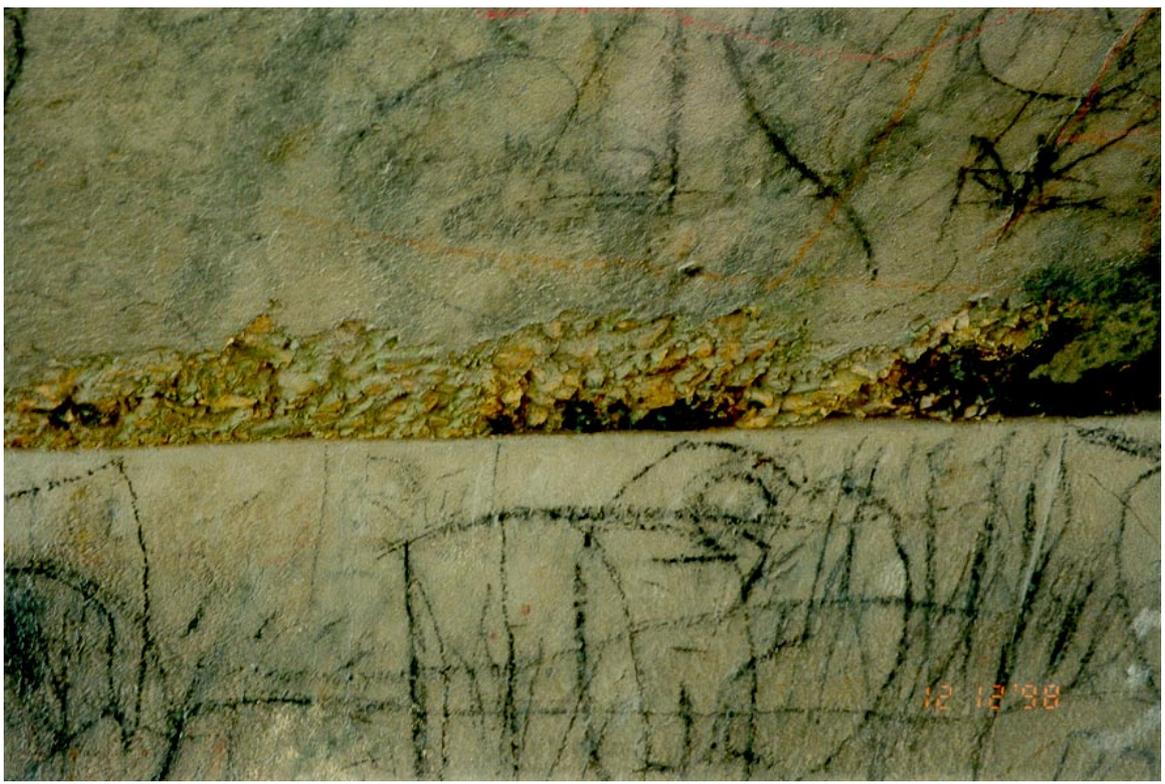
Figure 1.13 Casting defect in the soffit of the arch

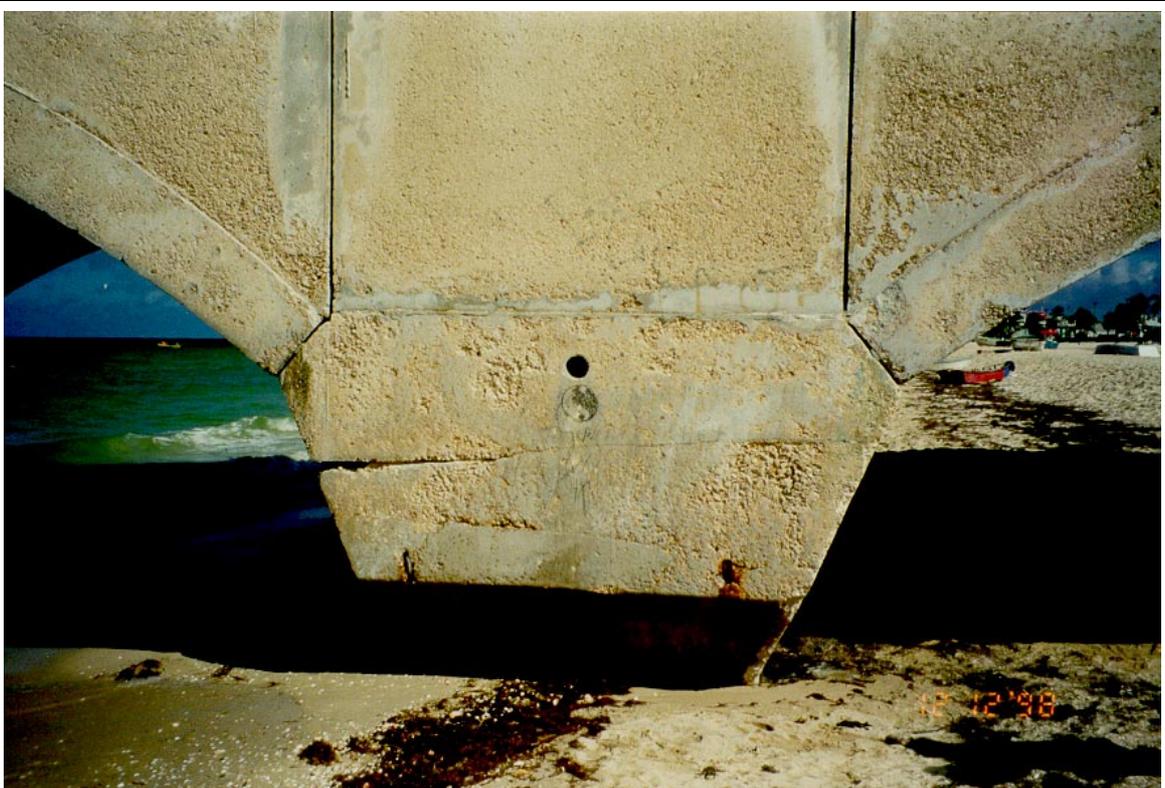
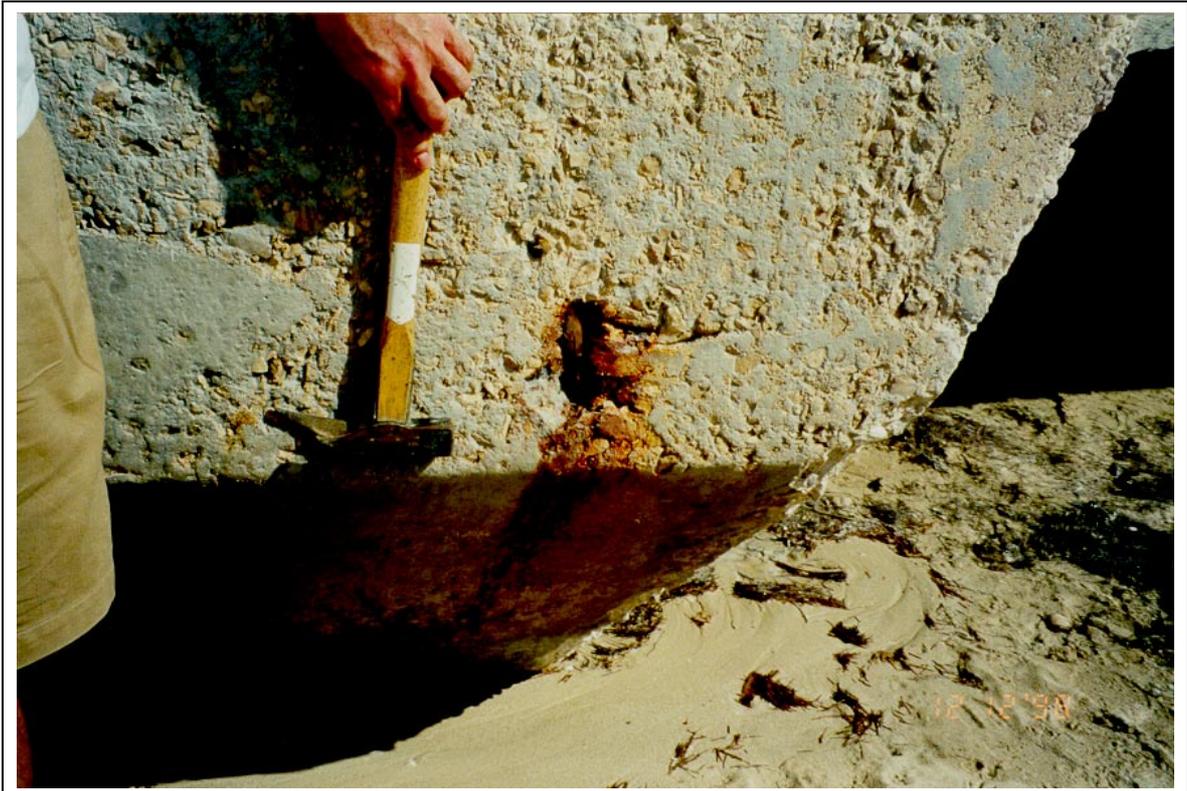
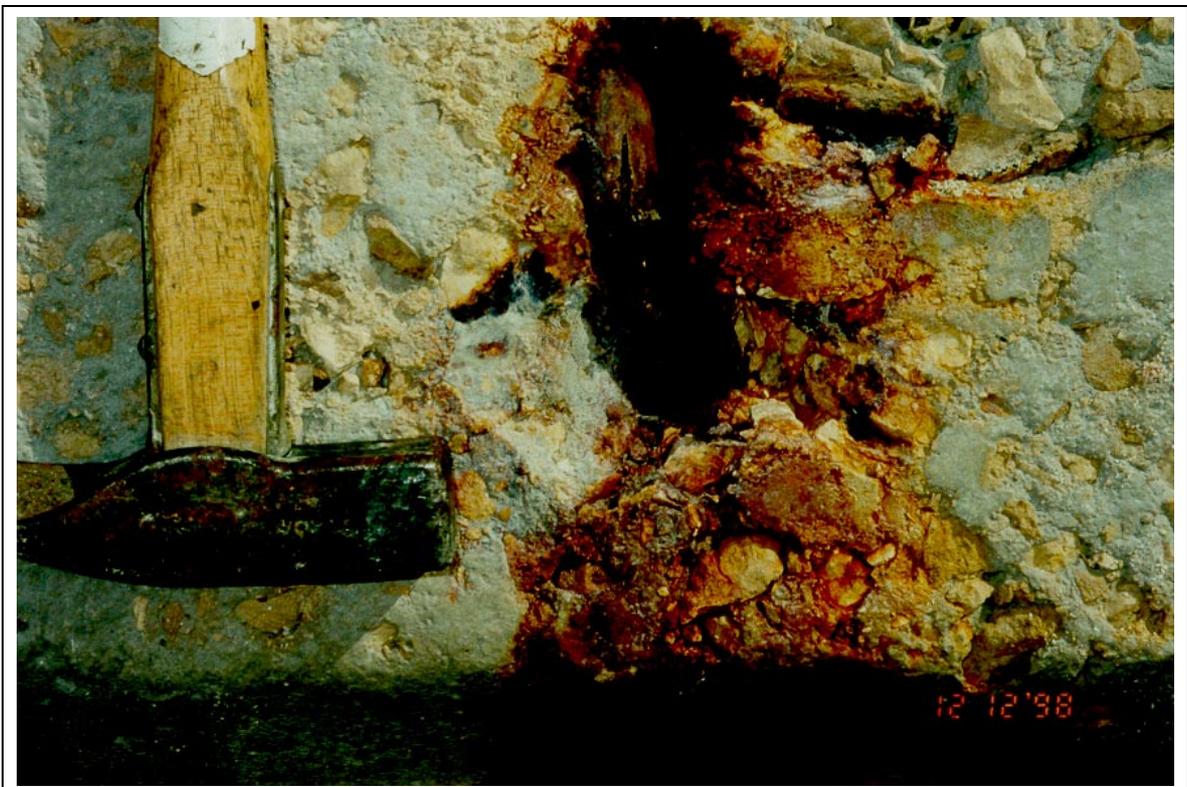
Figure 1.14 Visible reinforcement on west side of column no. 9

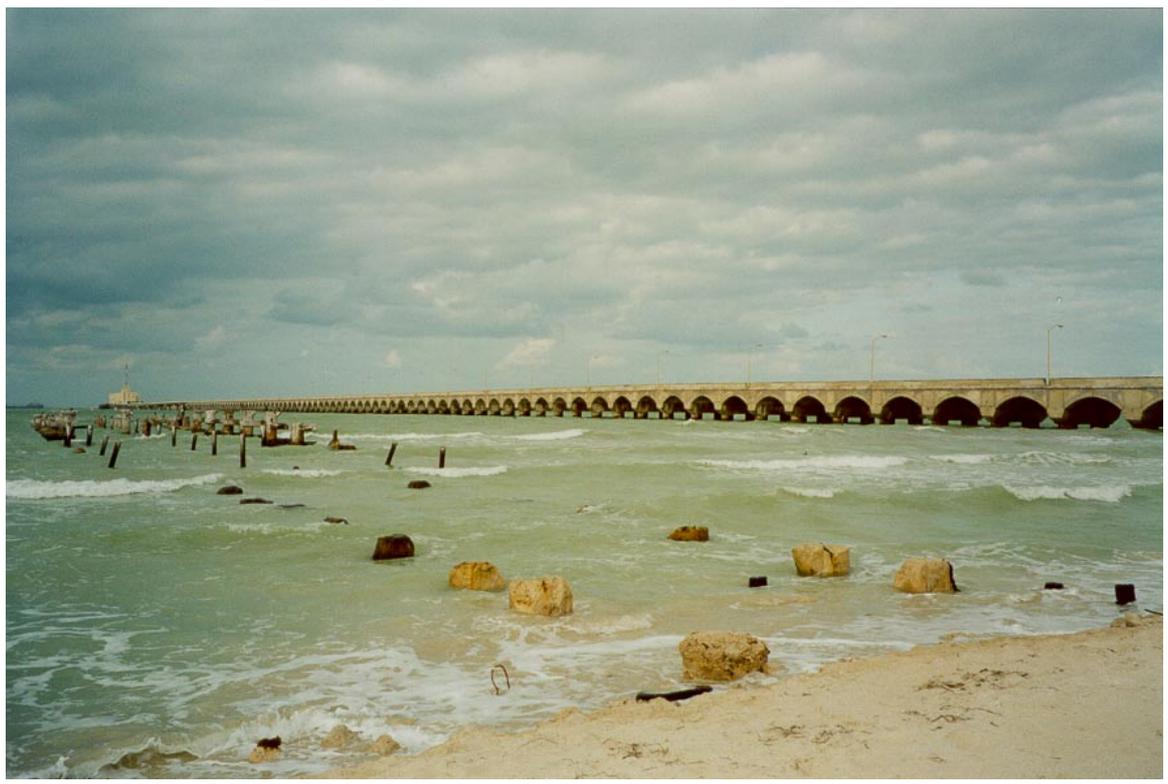
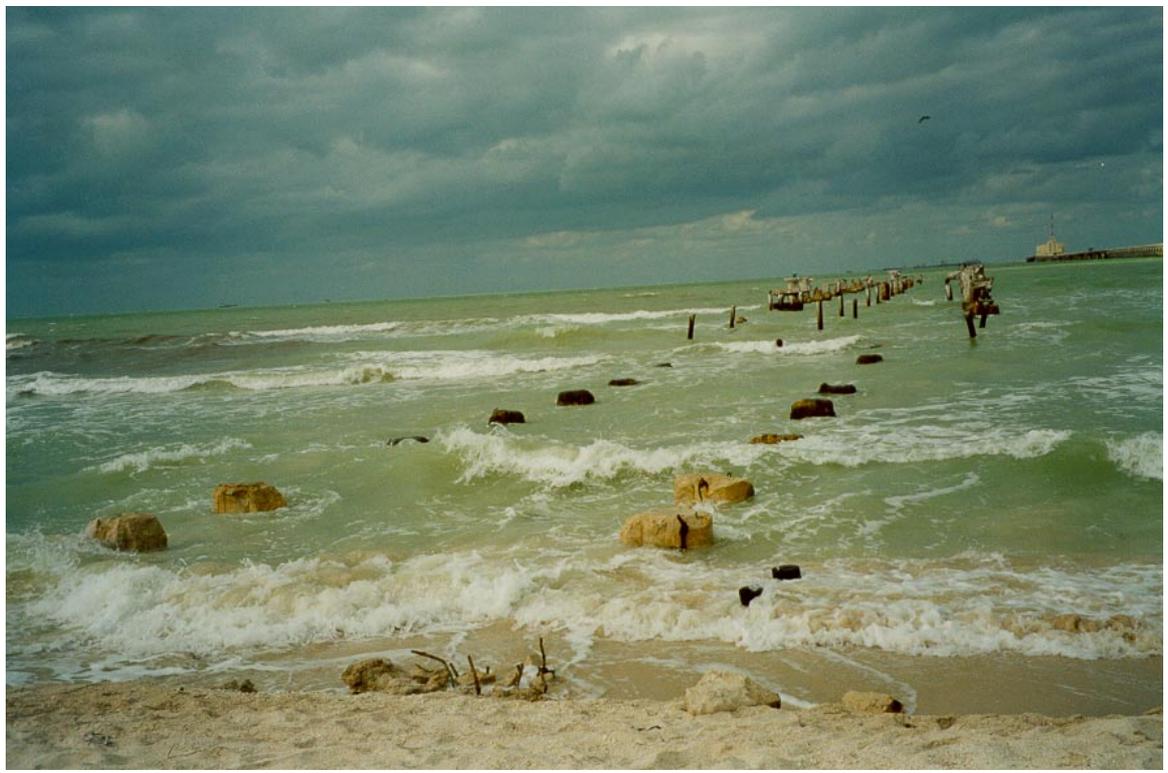
The remaining parts of a parallel neighbour pier are located approximately 200 m to the west of the investigated pier. The neighbour pier is heavily deteriorated and both columns and superstructure are almost completely gone, see figures 2.1 and 2.2 in Appendix 2.

Figure 2.1 Deteriorated concrete columns of neighbour pier located to the west of the inspected concrete pier

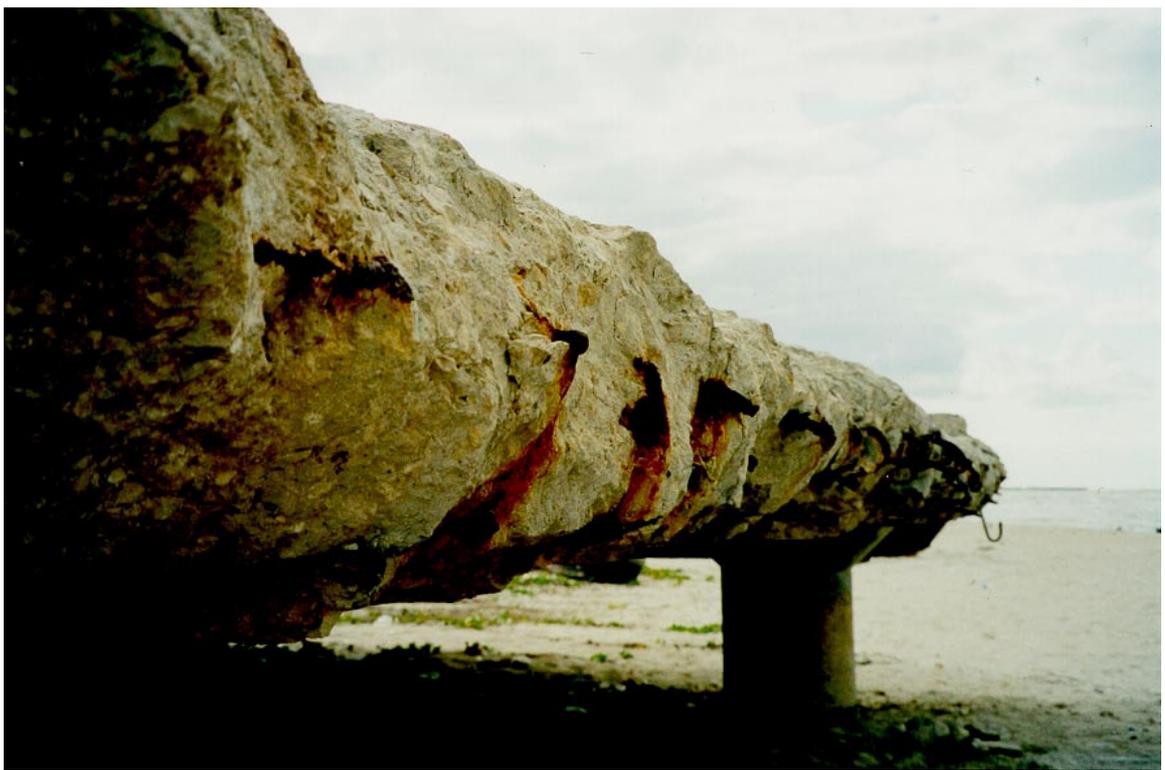
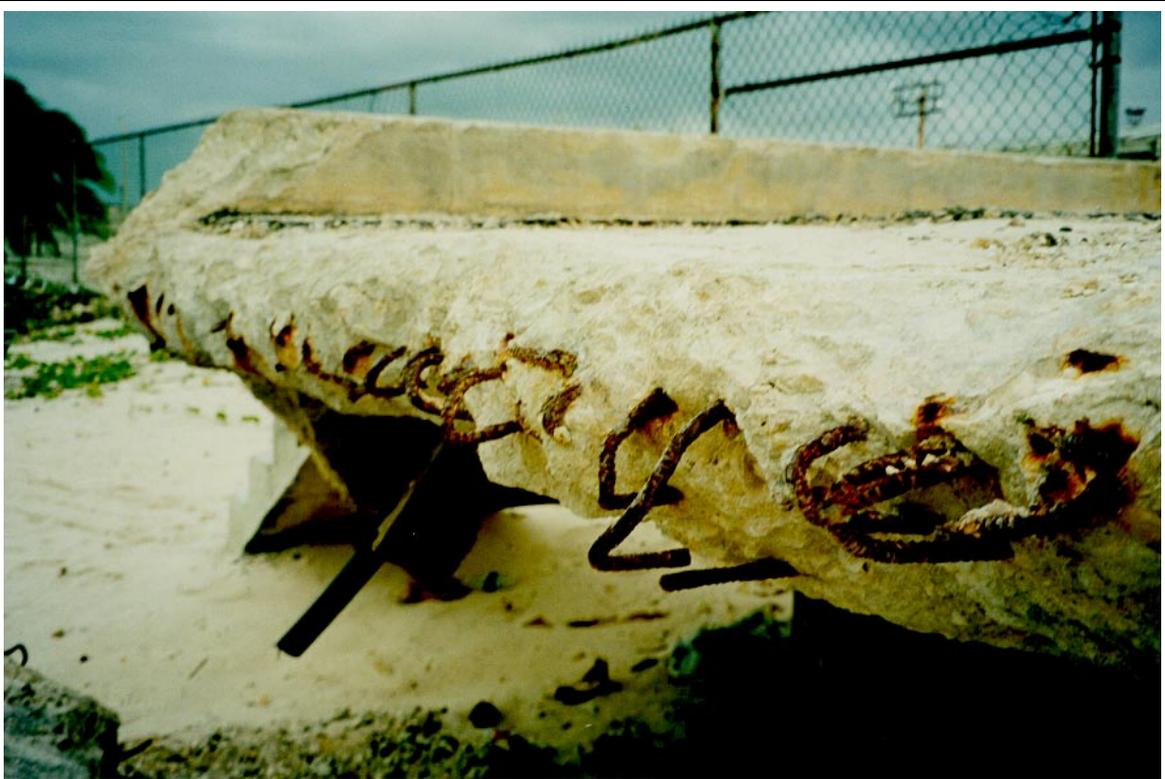
According to the Progreso Port Authorities /3/, this neighbour pier was built with carbon steel reinforcement approximately 30 years ago. There is severe corrosion damage on exposed reinforcement bars in the columns and deck of the neighbour pier, see figures 2.3 and 2.4 in Appendix 2, and in some cases pitting corrosion occur.

Figure 2.3 Pier deck of the neighbour pier

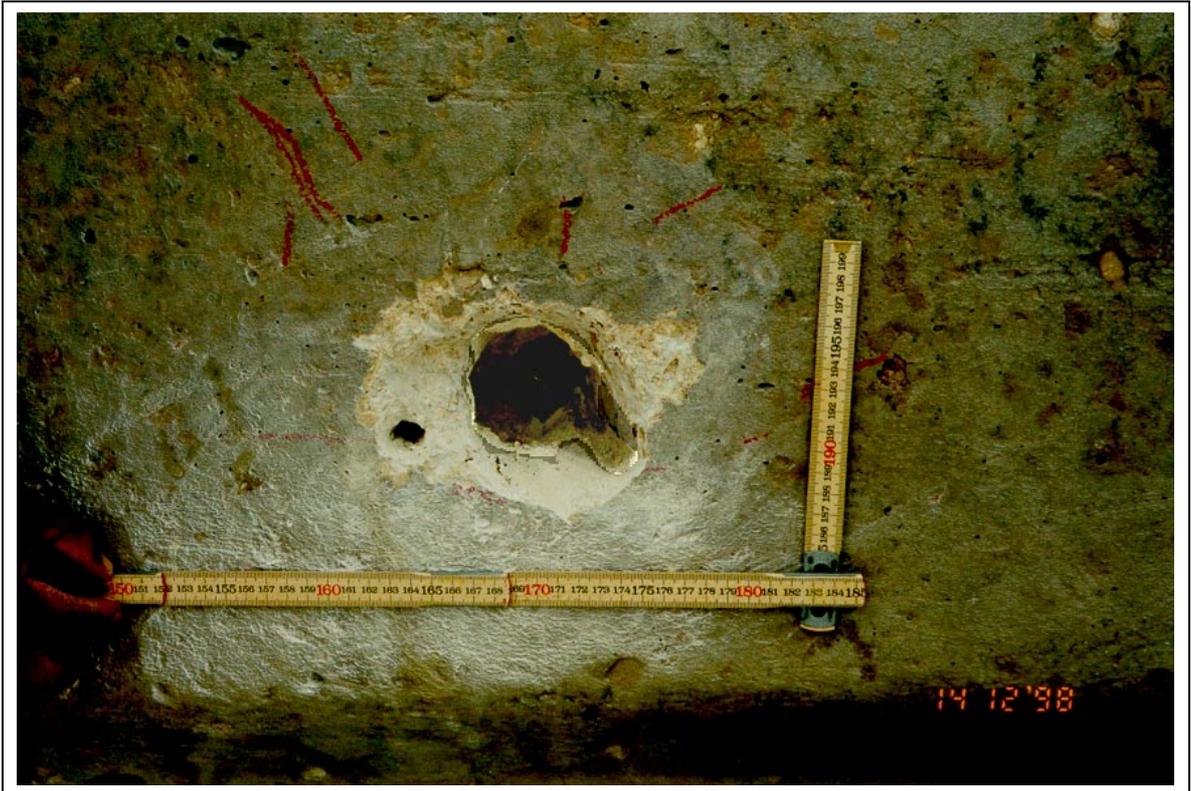
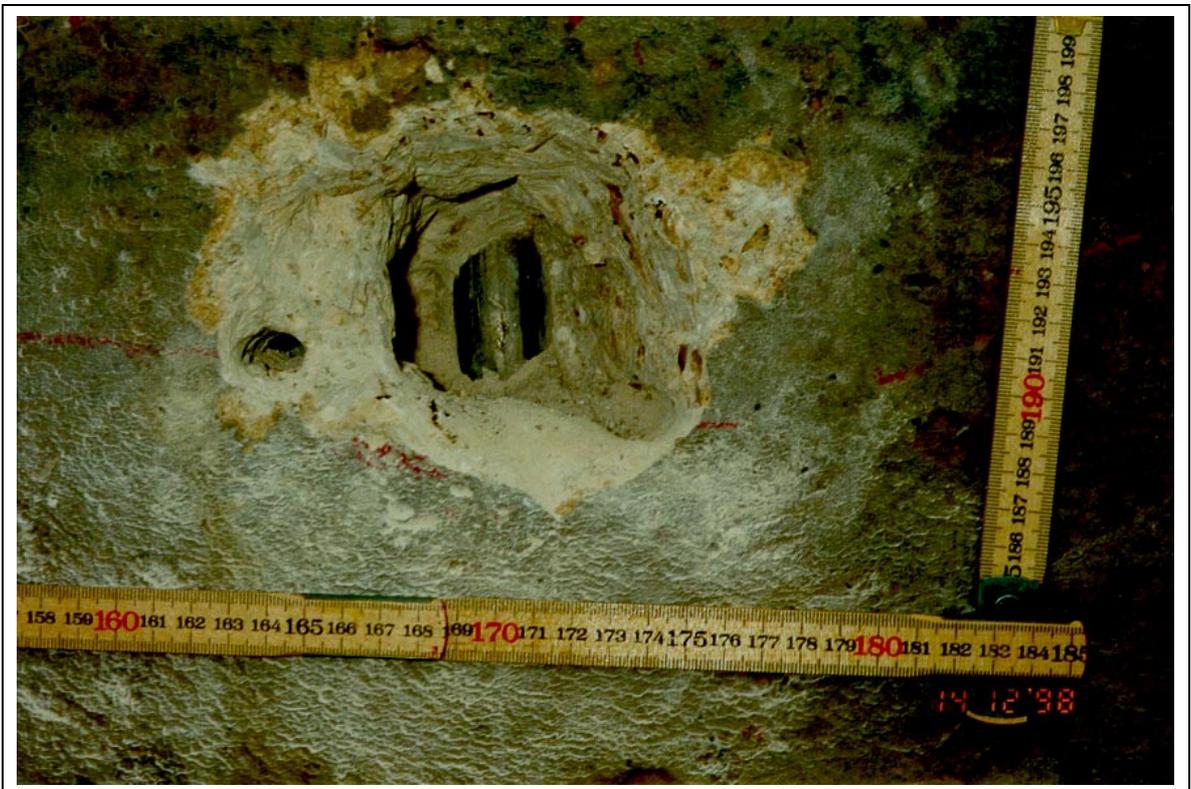
There was no corrosion on the reinforcement in break-up nos. 1 and 2 except for light surface corrosion on an area less than 5% in break-up no. 2. The cover was 105 mm in break-up no. 1 and 32 mm in break-up no. 2.

Break-up no. 1		
Location: Column no. 9, east side, see Figure 3.1		
Structural part	Description	Figure no.
Concrete	The concrete was hard and sounding. Chloride measurements were carried out.	3.1
Reinforcement	Vertical reinforcement (hairpin stirrup): - Cover 105 mm - Bar Ø30 mm - No corrosion (glossy)	3.3 3.4

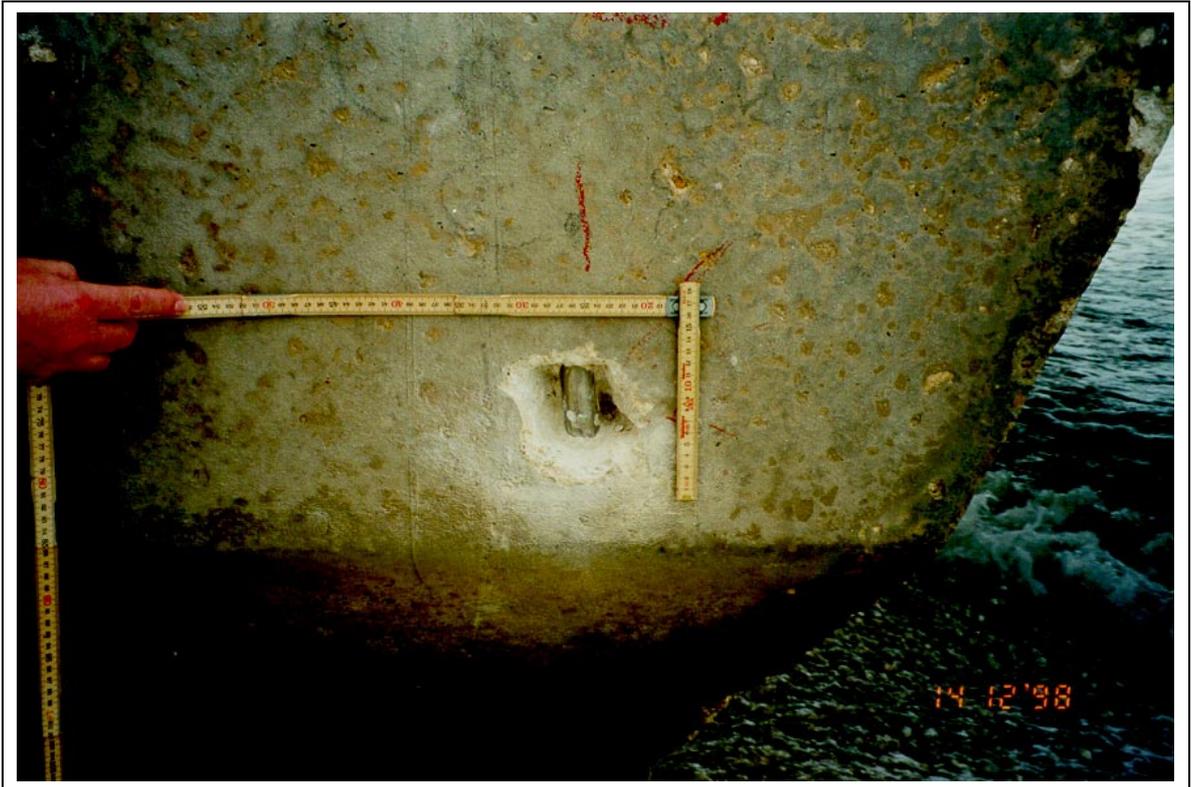
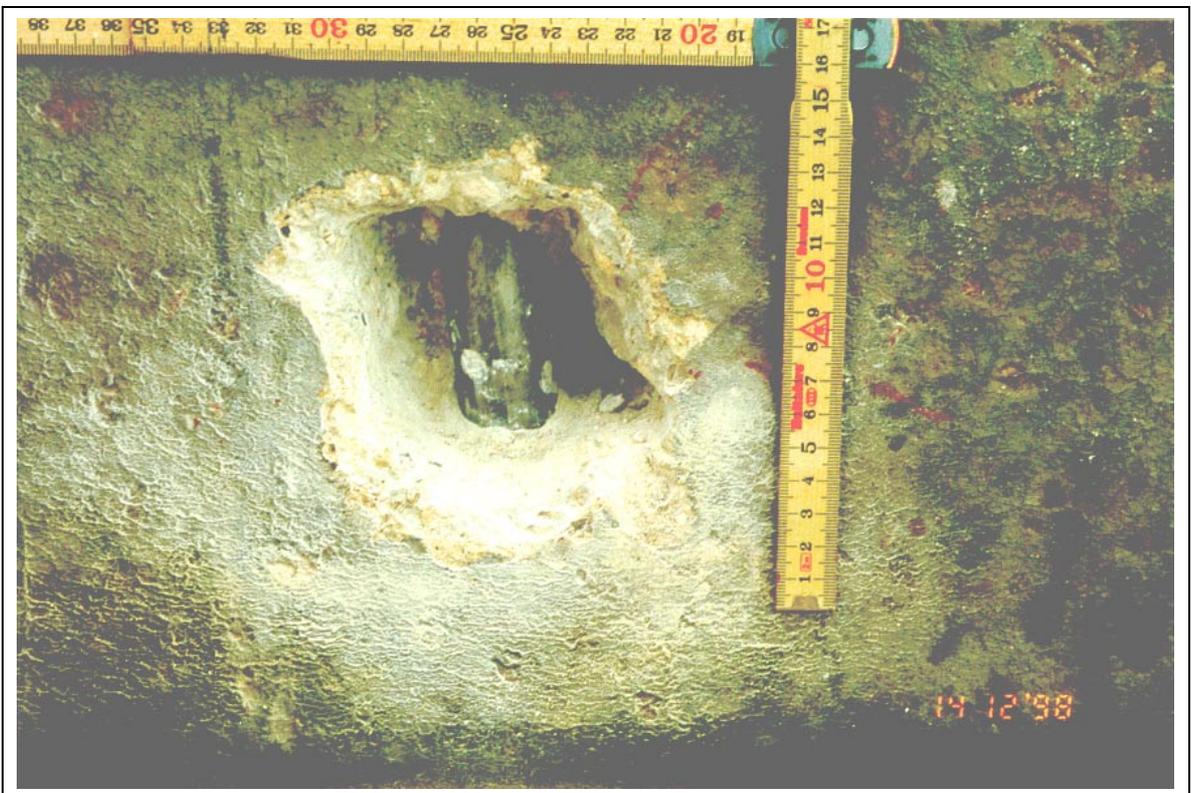
Break-up no. 2		
Location: Column no. 9, east side, see Figure 3.1		
Structural part	Description	Figure no.
Concrete	The concrete was hard and sounding. Chloride measurements were carried out.	3.1
Reinforcement	Vertical reinforcement (hairpin stirrup): - Cover 32 mm - Bar Ø30 mm - No corrosion (glossy) except for a very small area (< 5%) with light surface corrosion	3.5 3.6
