Pier in Progreso, Mexico.
Inspection Report
Evaluation of the Stainless Steel Reinforcement
March 1999

Inspection Report

Evaluation of the Stainless Steel Reinforcement

March 1999

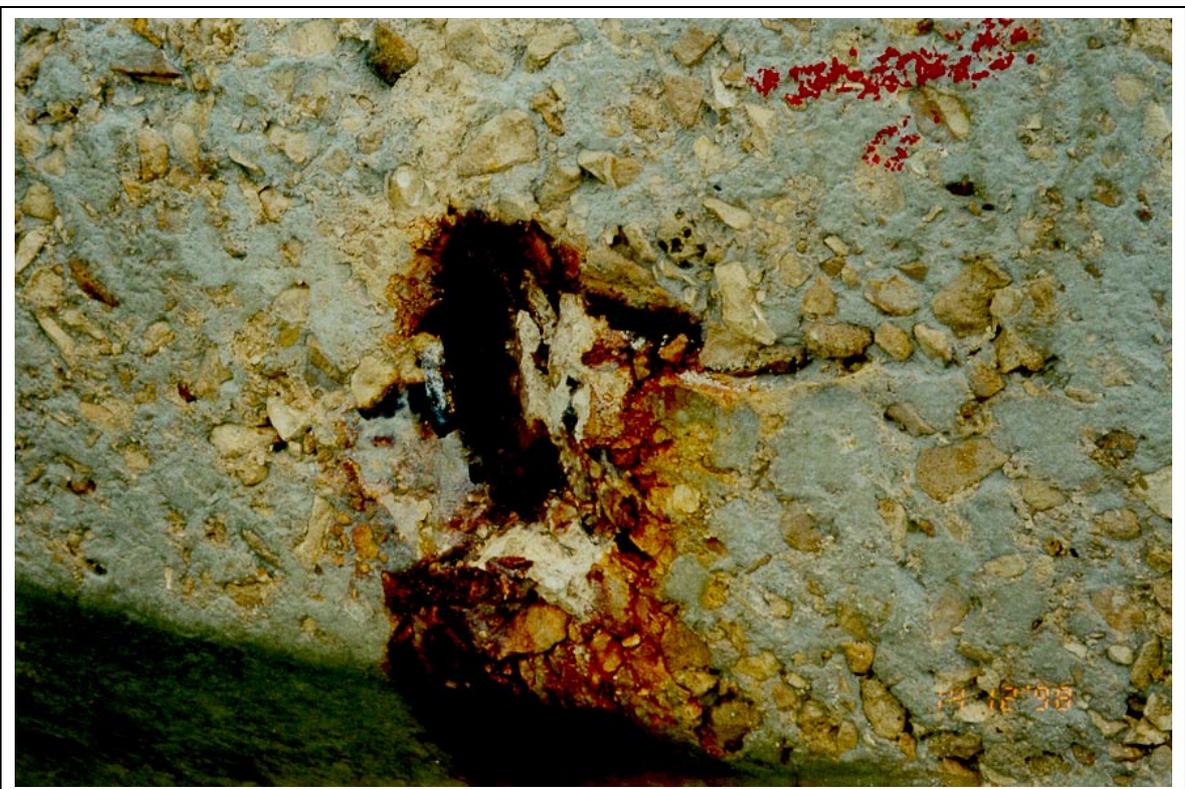
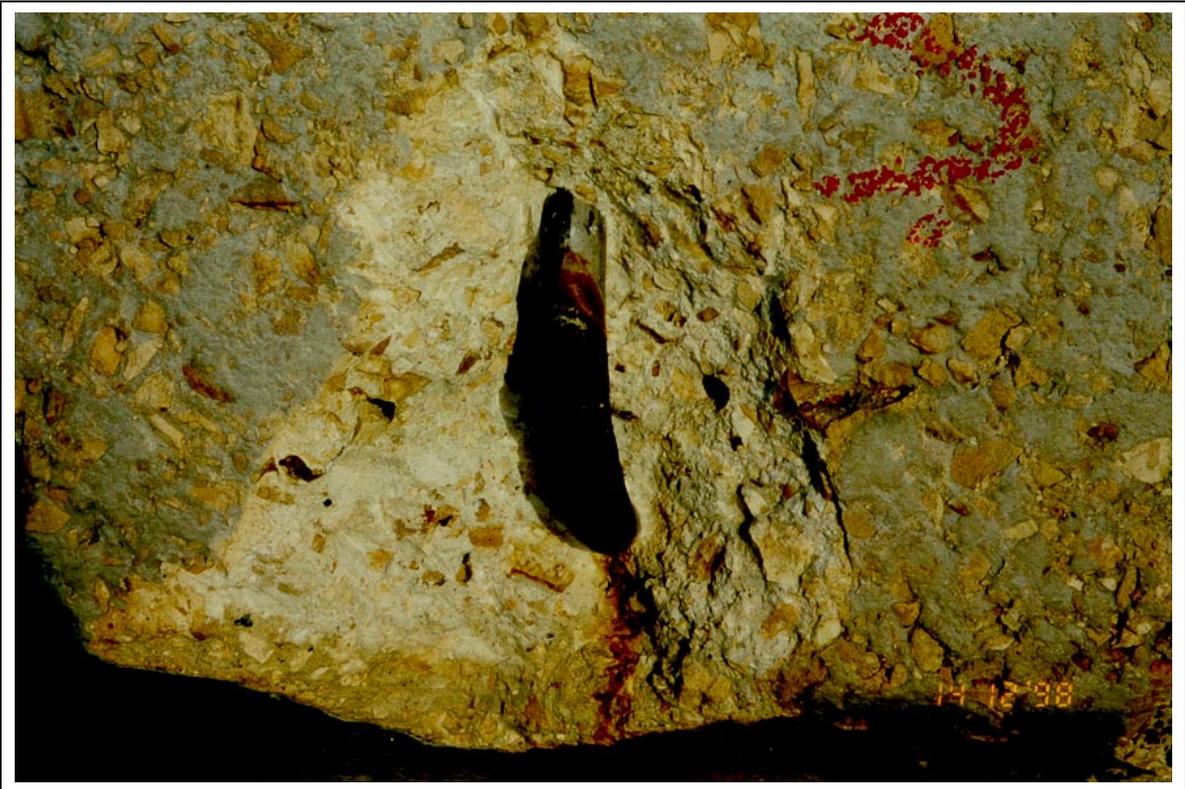
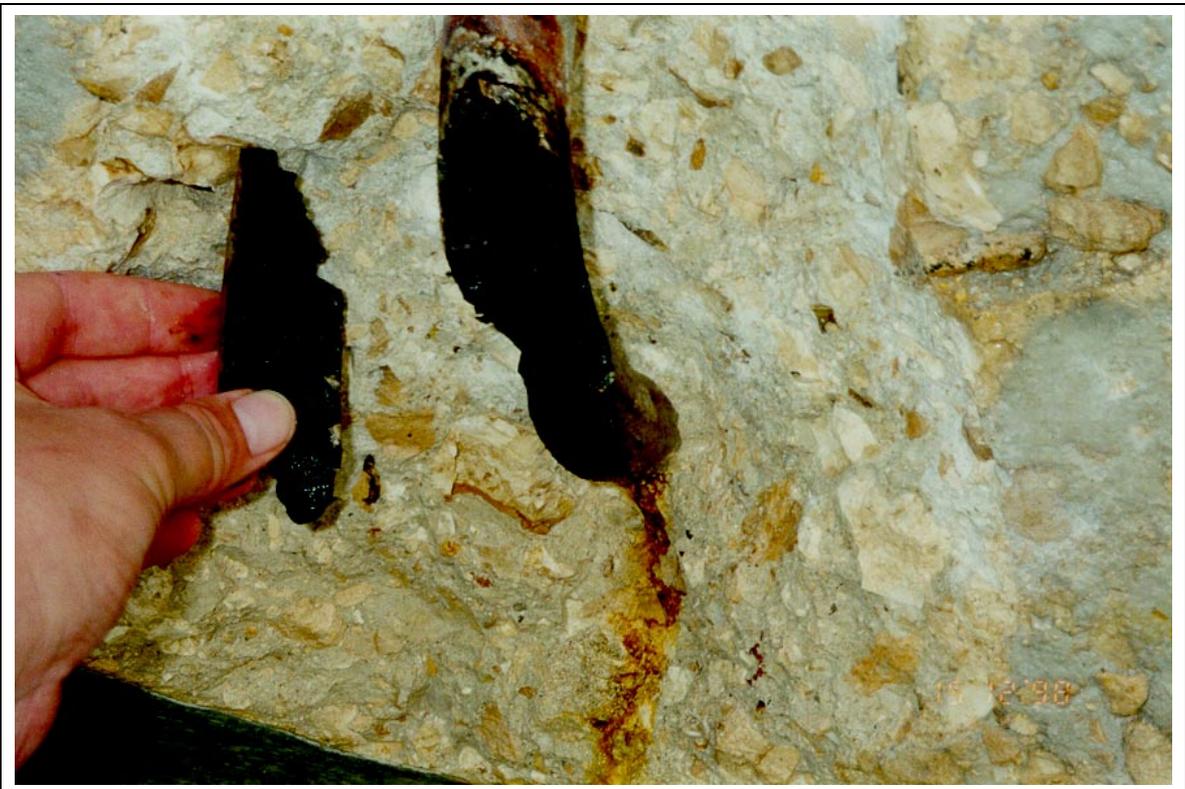
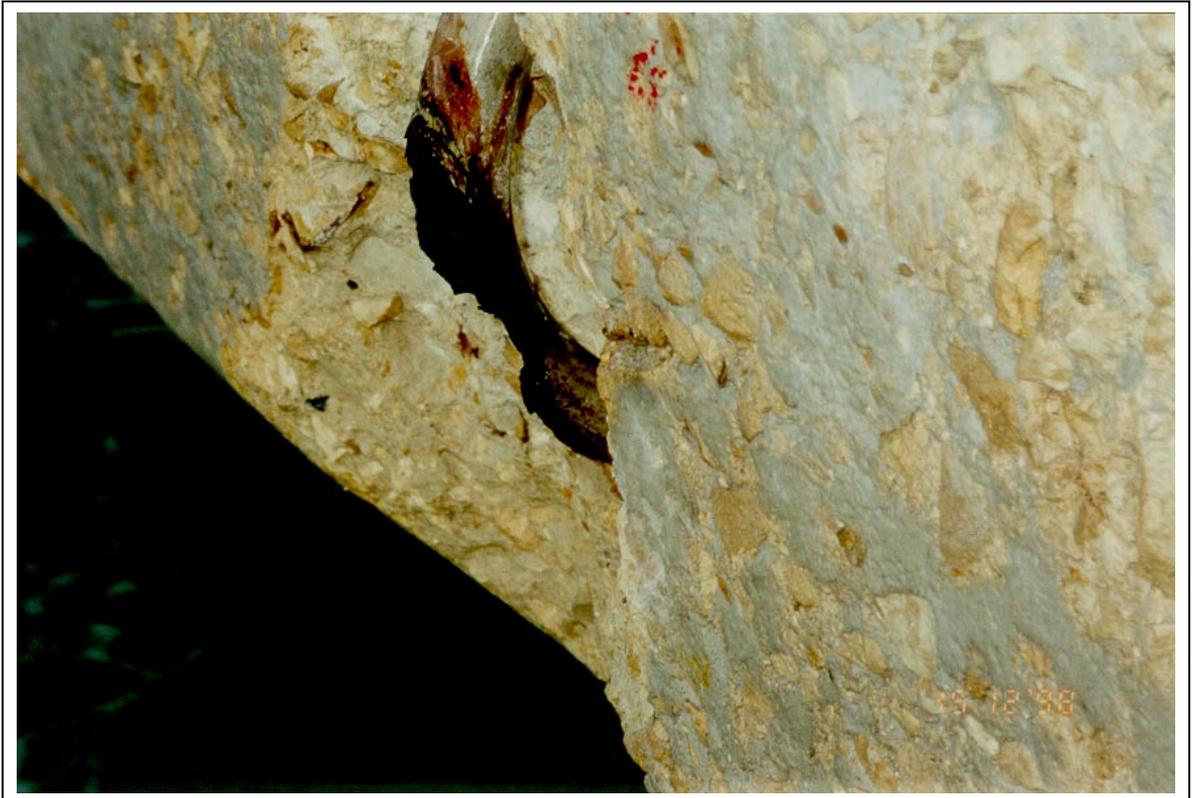
There was serious laminated corrosion on the exposed reinforcement having no cover in break-up nos. 3 and 4. At a depth of 18 mm in break-up no. 3 and 28 mm in break-up no. 4, there was no corrosion on the reinforcement except for light surface corrosion on an area less than 5% of the exposed reinforcement in break-up no. 3 and less than 20% of the exposed reinforcement in break-up no. 4.

Break-up no. 3		
Location: Column no. 9, west side, see Figure 3.2		
Structural part	Description	Figure no.
Concrete	<p>The concrete was hard, but not sounding.</p> <p>Large honeycombs were located just above the break-up.</p> <p>Chloride measurements were carried out.</p> <p>A concrete sample was taken out for petrographic analysis.</p>	<p>3.2</p> <p>3.7</p> <p>3.8</p>
Reinforcement	<p>Vertical reinforcement (hairpin stirrup):</p> <ul style="list-style-type: none"> - Cover 0 mm (visible reinforcement) - Bar Ø30 mm - Serious laminated corrosion on reinforcement part with no cover - 18 mm inside the concrete there was no corrosion except for light surface corrosion on a very small area (< 5%) - A reinforcement sample was taken out for optical emission spectroscopy analysis. After the reinforcement sample was taken out, the reinforcement area was reduced to approximately 20-30%. 	<p>3.9</p> <p>3.10</p> <p>3.11</p>

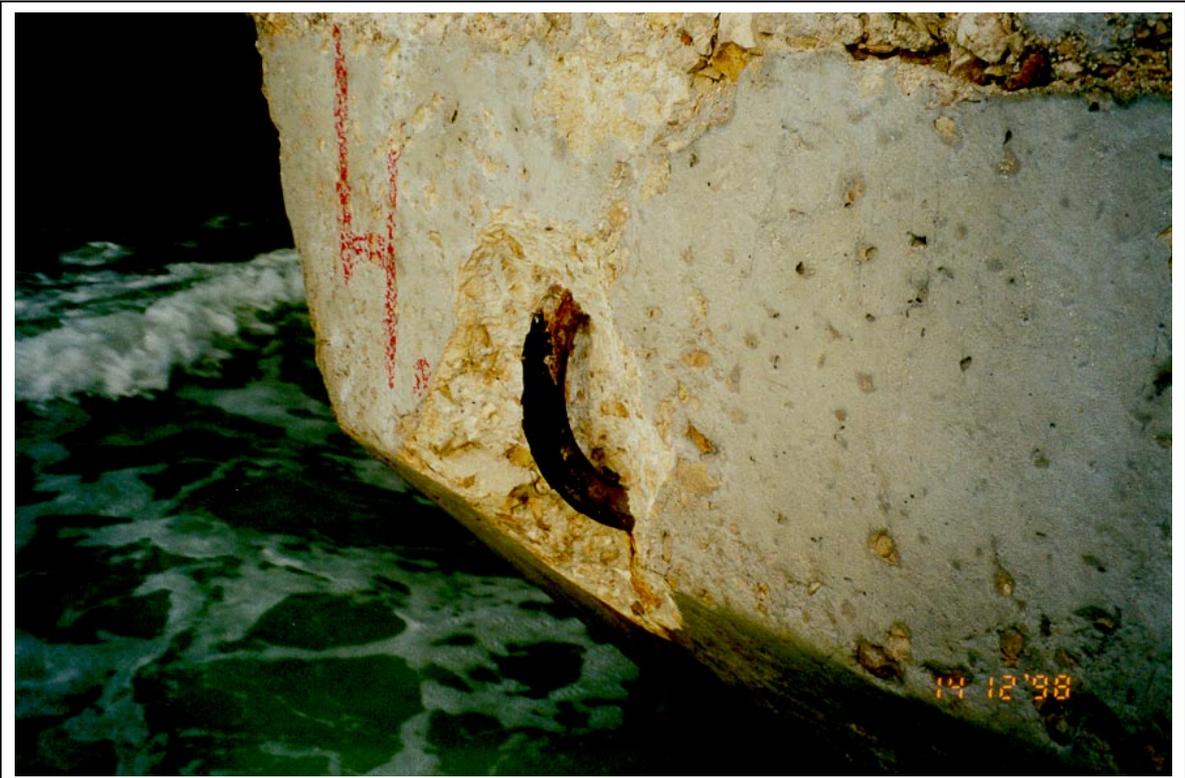
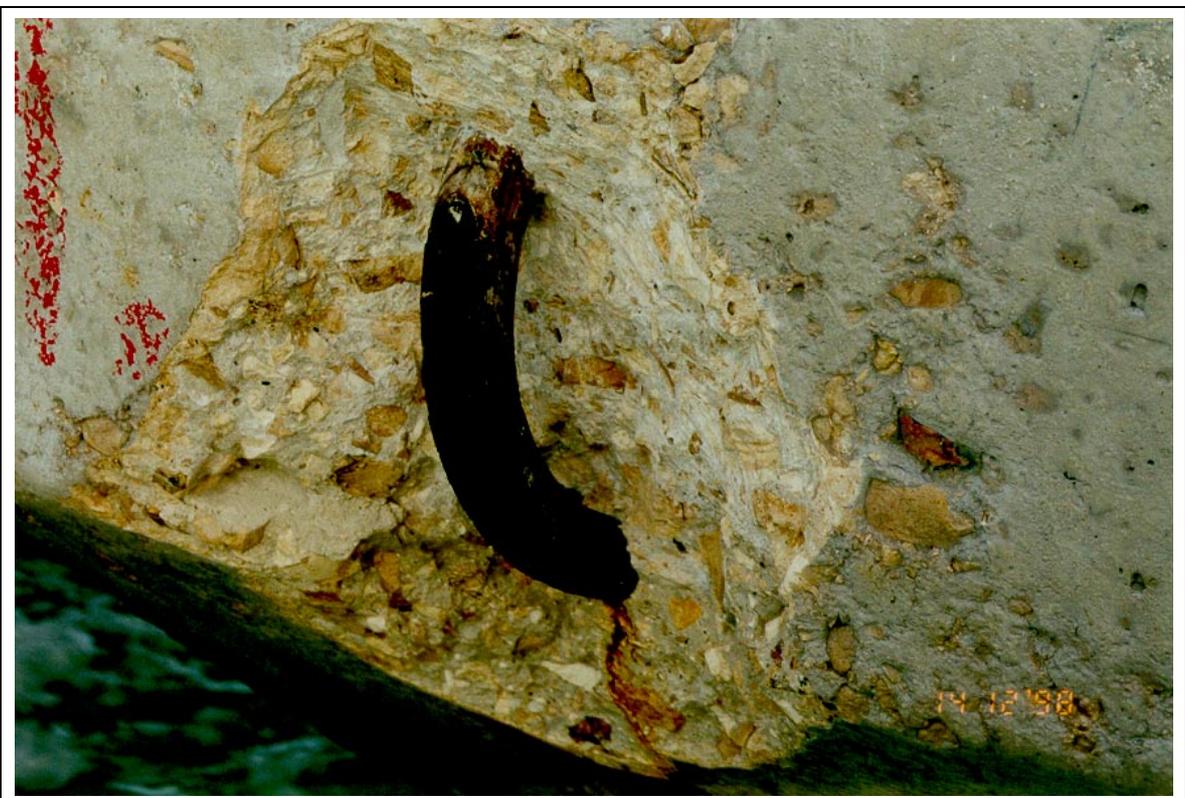
Break-up no. 4		
Location: Column no. 9, west side, see Figure 3.2		
Structural part	Description	Figure no.
Concrete	<p>The concrete was hard, but not sounding.</p> <p>Large honeycombs were located just above the break-up.</p>	<p>3.2</p> <p>3.7</p>
Reinforcement	<p>Vertical reinforcement (hairpin stirrup):</p> <ul style="list-style-type: none"> - Cover 0 mm (visible reinforcement) - Bar Ø30 mm - Serious laminated corrosion on reinforcement part with no cover (reinforcement area is reduced to approx. 40-50%) - 28 mm inside the concrete, there was no corrosion except for light surface corrosion on a limited area (< 20%) 	<p>3.12</p> <p>3.13</p>

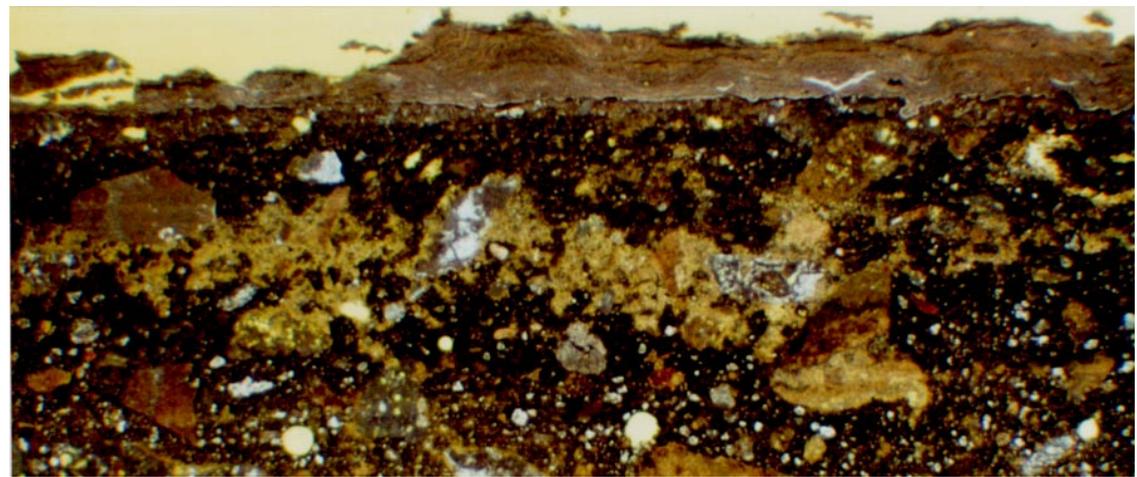
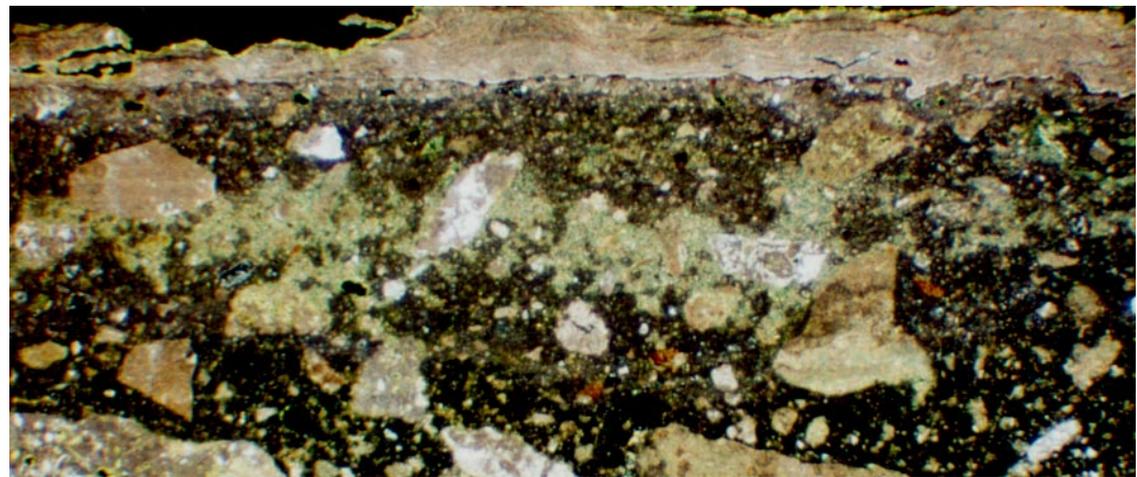
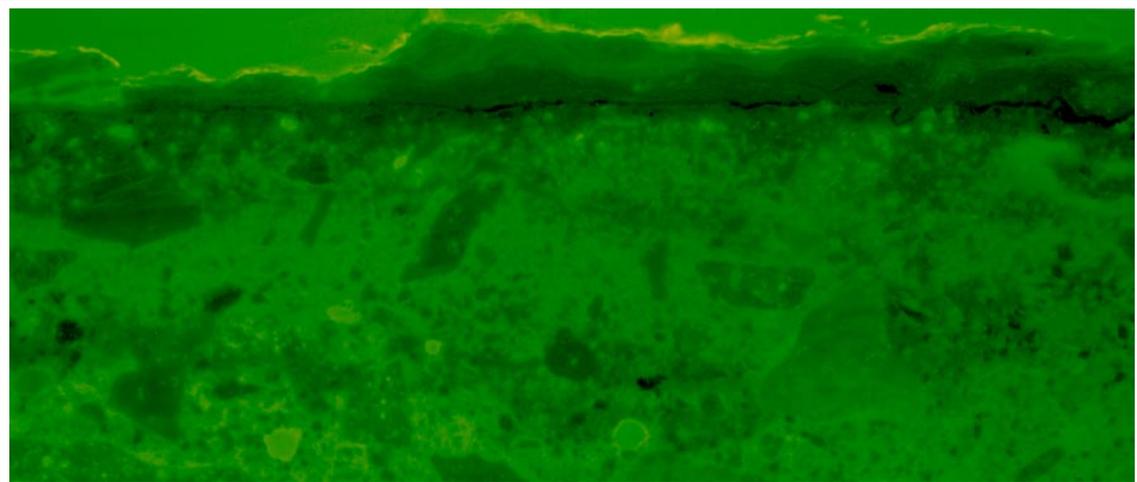
A thin relative dense layer (approx. 0.5 mm) of calcium carbonate is observed on the surface.

Micrographs showing the surface of the concrete. A thin relative dense layer of carbonate is seen cover the concrete surface. The photos are taken in ordinary, crossed polarized and fluorescent light (same field of view): approx. 6 x 3 mm.

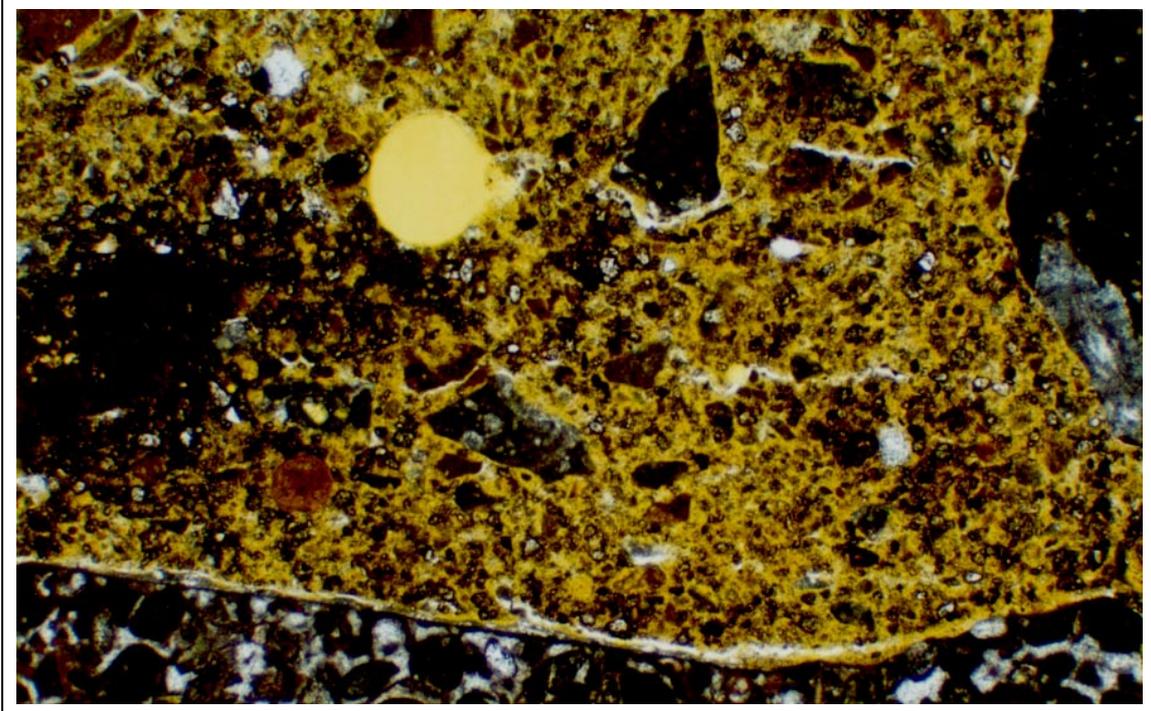
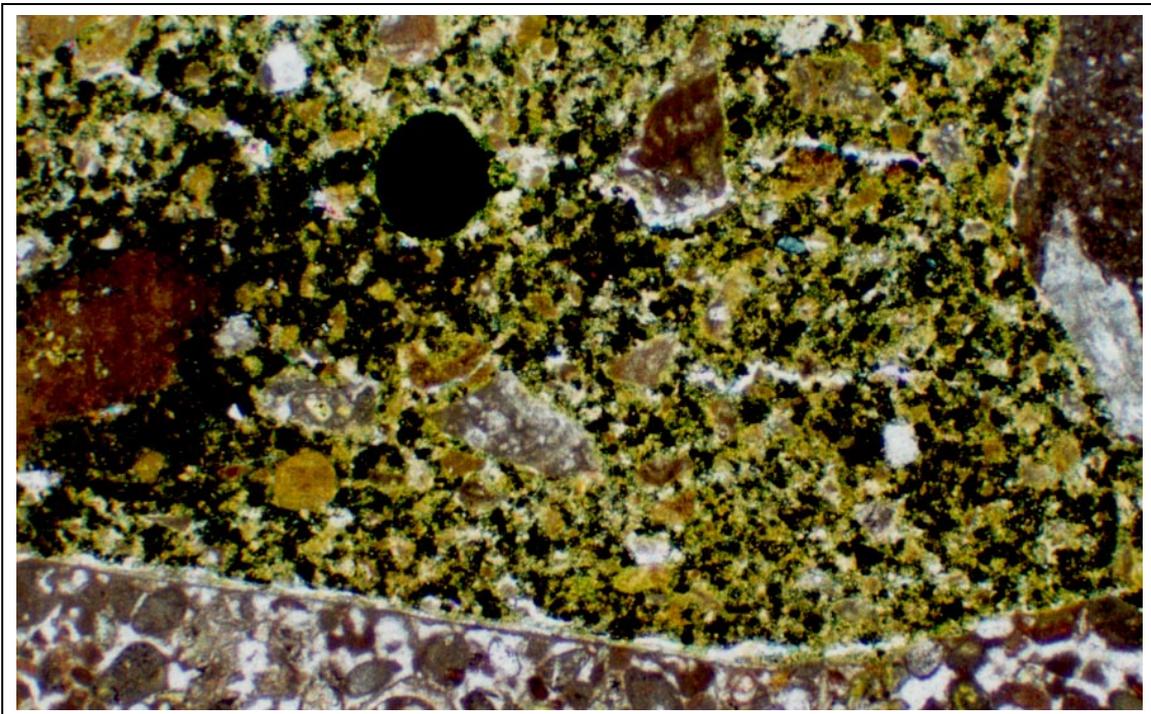
The concrete contains a relatively high amount of fine plastic paste and adhesion cracks. These cracks are partly filled with portlandite (Ca(OH)₂), indicating internal bleeding of the concrete. The mean carbonation depth is low and varies from approximately 0 to 0.5 mm. The paste is, however, partly carbonated around air voids and porosities throughout the sample.

Micrographs showing a relatively high amount of fine plastic paste and adhesion cracks. The cracks are partly filled with $\text{Ca}(\text{OH})_2$. The photos are taken in ordinary and crossed polarized light (same field of view) approx. 4.2 x 2.7 mm.

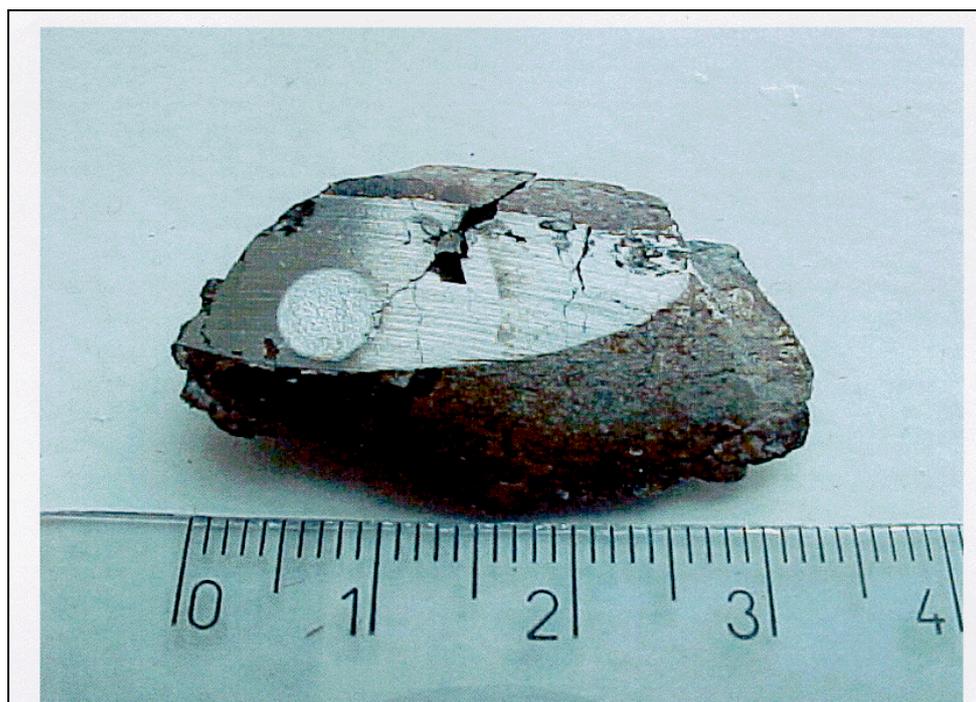
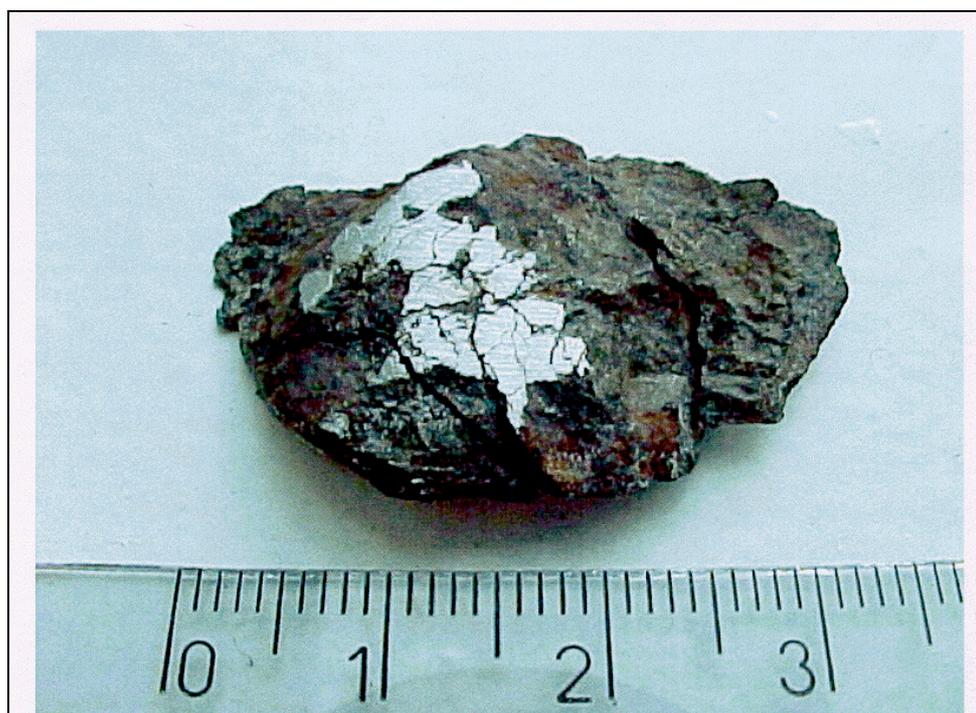
As a part of the preparation for the chemical analysis, the surfaces of the sample were polished. After this treatment, several cracks through the steel could be seen, see Figure 1 and 2. In order to study the microstructure and these cracks more closely, a microsection of the sample was prepared.

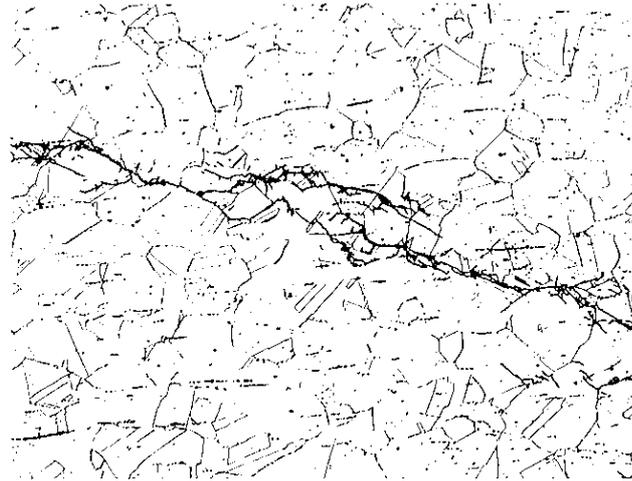
From the characteristic transgranular crack morphology shown in Figure 3, these cracks can be characterized as stress corrosion cracking (SCC).

As regards corrosion resistance, the steel sample was heavily attacked by stress corrosion cracking (SCC). It should, however, be noted that this attack is not related to any weakness of the steel, such as sensitization due to intergranular precipitates. It is believed that the attack is purely a result of the aggressive conditions on the freely exposed surfaces of the steel bars. The critical conditions for stress corrosion cracking of the 18-8-grade may here easily be exceeded, i.e. temperatures above 50°C due to the sunlight, evaporation of chloride containing solutions from the salt mist and high tensile stresses in the steel bar. The same critical conditions cannot be expected for the embedded steel bars, since the temperature and chloride content here will be significantly lower. The reduced access of air as well as the alkalinity and composition of the concrete will also significantly reduce the risk of corrosion of the steel bars within the concrete.

Figure 3. Stress corrosion cracks in the sample. Electrolytically etched in oxalic acid. Magn.: x180.

Based on these considerations, we expect that the stainless steel bars within the concrete are well protected and possibly preserved in the original condition. It is, however, recommended that this be verified by further assessments, e.g. chemical analysis of the pore water in concrete.

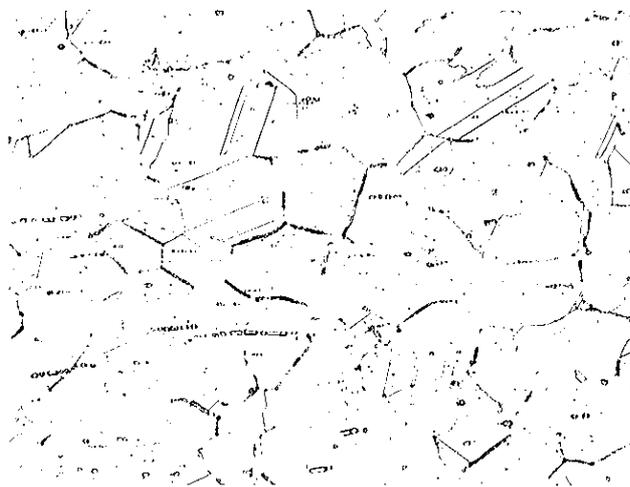
The microstructure of an undamaged part of the sample is shown in Figure 4. This picture shows a typical and acceptable austenitic structure characterized by relatively coarse grains with twins. From the grain structure, it is assumed that the steel is delivered in a hot-finished and annealed condition. The inclusions orientated along the rolling direction are possibly slag particles.

Figure 4. Microstructure of the sample. Electrolytically etched in oxalic acid. Magn.: x370.
