Pier in Progreso, Mexico.
Inspection Report
Evaluation of the Stainless Steel Reinforcement
March 1999

Inspection Report

Evaluation of the Stainless Steel Reinforcement

March 1999

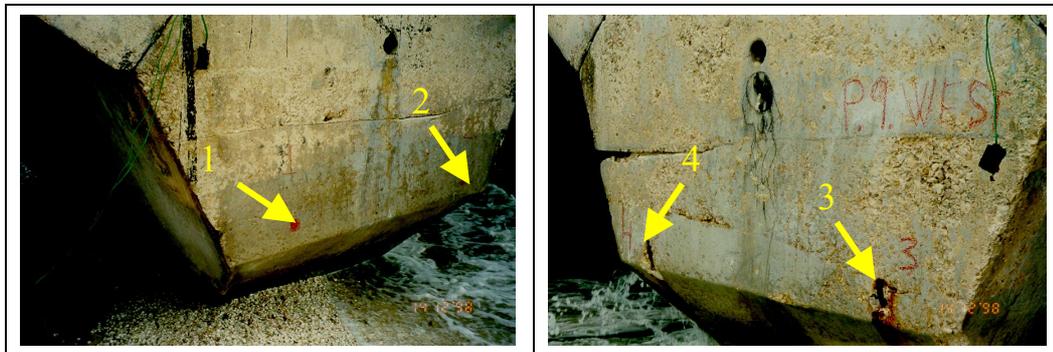
The concrete was hard and sounding at break-up nos. 1 and 2, and hard, but not sounding at break-up nos. 3 and 4.

There was no corrosion on the reinforcement in break-up nos. 1 and 2 except for light surface corrosion on an area less than 5% in break-up no. 2. The cover was 105 mm in break-up no. 1 and 32 mm in break-up no. 2.

Figure 2 Location of break-ups nos. 1 and 2 (to the left) and 3 and 4 (to the right) on column no. 9

There was serious laminated corrosion on the exposed reinforcement having no cover in break-up nos. 3 and 4. At a depth of 18 mm in break-up no. 3 and 28 mm in break-up no. 4, there was no corrosion on the reinforcement except for light surface corrosion on an area less than 5% of the exposed reinforcement in break-up no. 3 and less than 20% of the exposed reinforcement in break-up no. 4.

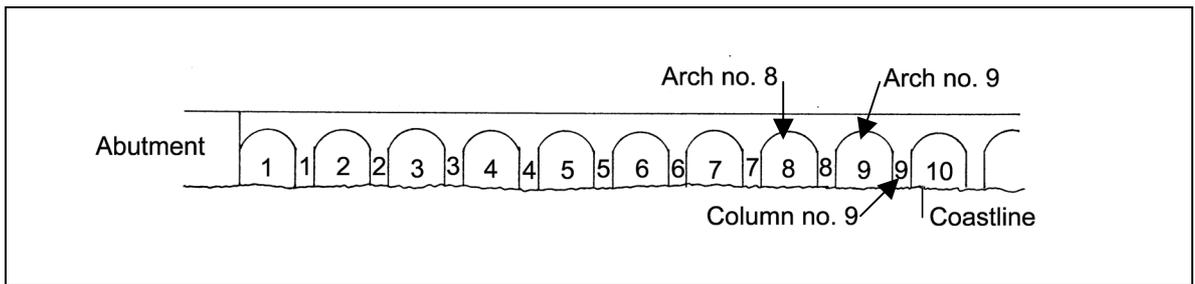
Due to strong on-shore wind and high waves, it was not possible to inspect the pier from boat. Detailed visual inspection was limited to the arches in span nos. 8 and 9 and column no. 9 between span nos. 9 and 10, see Figure 1.1 in Appendix 1, as these structural parts could be inspected from the beach without a boat. In addition, a superficial visual inspection of span nos. 1 to 7 was carried out from the beach and the remaining spans were inspected very superficially from the superstructure of the pier and the pier head.

Figure 1.1 Sketch showing the areas selected for detailed visual inspection

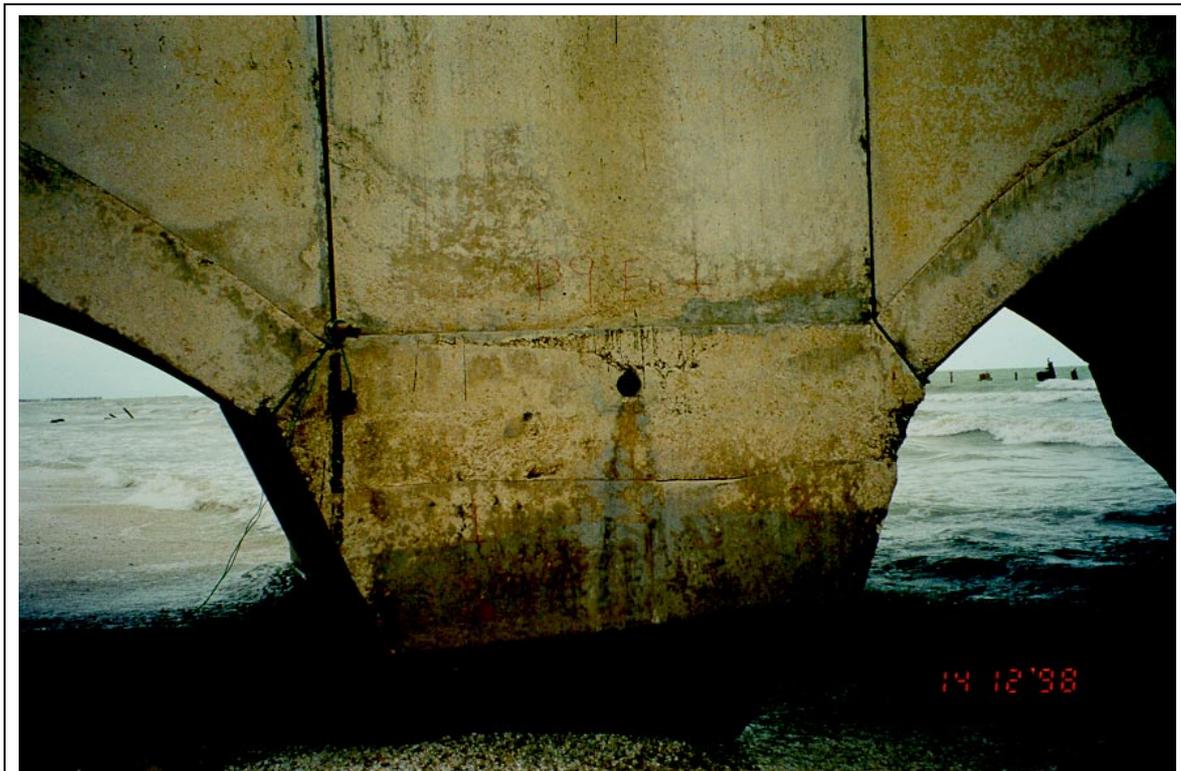
Column no. 9 is located exactly along the coastline which means that it is heavily exposed to seawater, see figure 1.2 in Appendix 1.

Figure 1.2 East side of column no. 9 located along the coastline

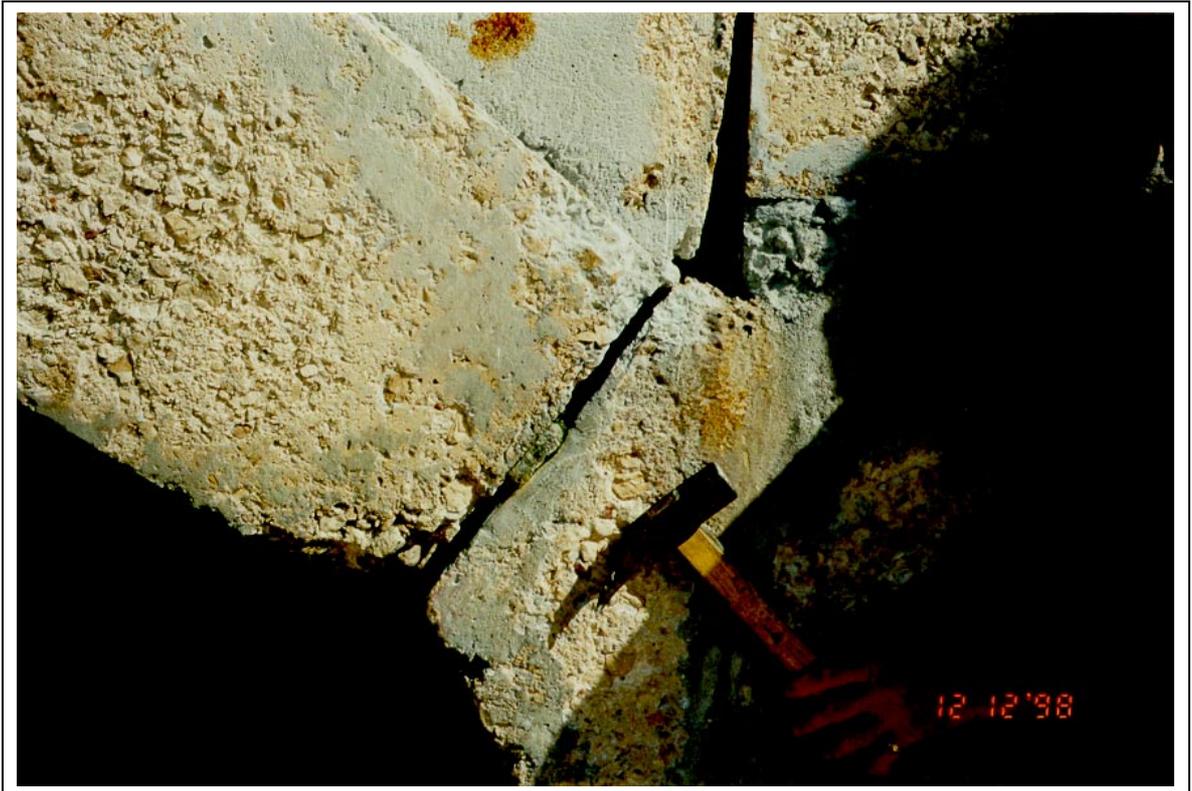
- There are joints between the columns and arches and in the middle of the spans, see figures 1.7 and 1.8 in Appendix 1. No reinforcement is visible in the joints, but a bearing plate is located in the joint between the arches and columns, see figure 1.7 in Appendix 1.

Figure 1.7 Joint gab and bearing plate between column and arch, column no. 9

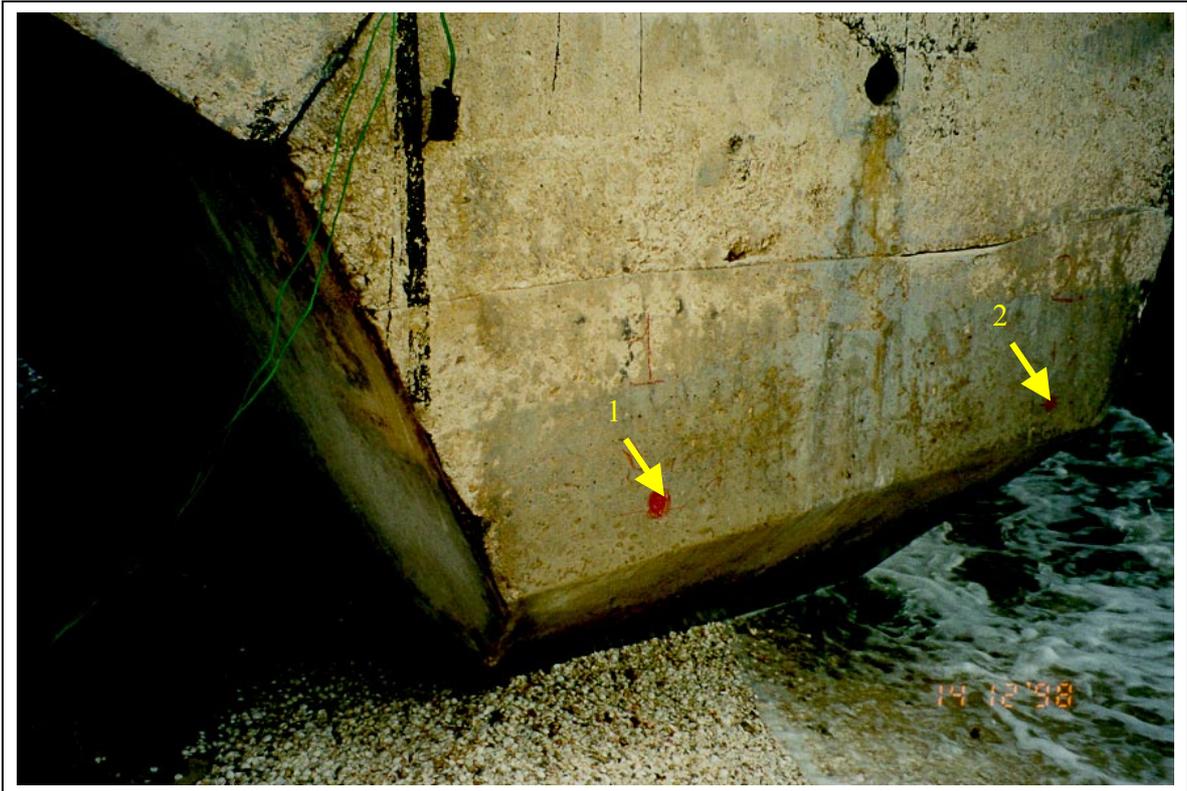
Figure 3.1 Location of break-ups 1 and 2, east side of column no. 9

Break-up no. 1		
Location: Column no. 9, east side, see Figure 3.1		
Structural part	Description	Figure no.
Concrete	The concrete was hard and sounding. Chloride measurements were carried out.	3.1
Reinforcement	Vertical reinforcement (hairpin stirrup): - Cover 105 mm - Bar Ø30 mm - No corrosion (glossy)	3.3 3.4

Break-up no. 2		
Location: Column no. 9, east side, see Figure 3.1		
Structural part	Description	Figure no.
Concrete	The concrete was hard and sounding. Chloride measurements were carried out.	3.1
Reinforcement	Vertical reinforcement (hairpin stirrup): - Cover 32 mm - Bar Ø30 mm - No corrosion (glossy) except for a very small area (< 5%) with light surface corrosion	3.5 3.6

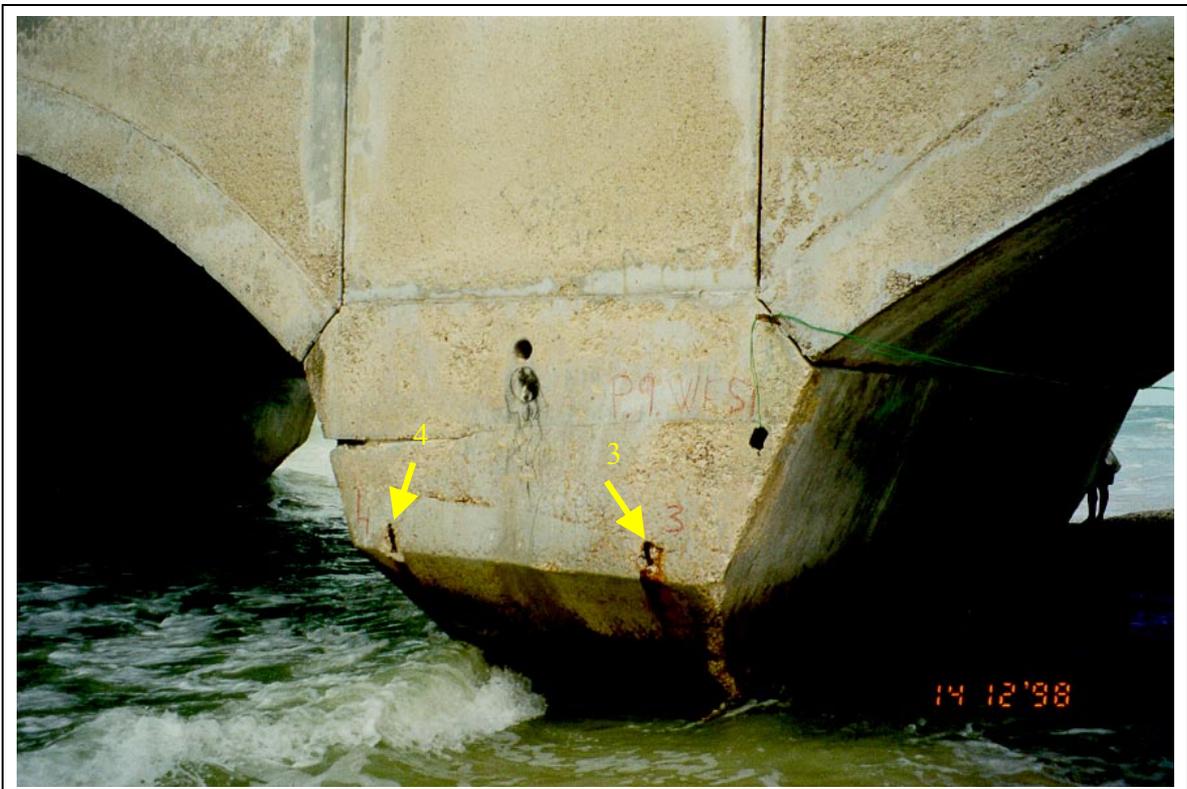
Figure 3.2 Location of break-ups 3 and 4, west side of column no. 9

Break-up no. 3		
Location: Column no. 9, west side, see Figure 3.2		
Structural part	Description	Figure no.
Concrete	<p>The concrete was hard, but not sounding.</p> <p>Large honeycombs were located just above the break-up.</p> <p>Chloride measurements were carried out.</p> <p>A concrete sample was taken out for petrographic analysis.</p>	<p>3.2</p> <p>3.7</p> <p>3.8</p>
Reinforcement	<p>Vertical reinforcement (hairpin stirrup):</p> <ul style="list-style-type: none"> - Cover 0 mm (visible reinforcement) - Bar Ø30 mm - Serious laminated corrosion on reinforcement part with no cover - 18 mm inside the concrete there was no corrosion except for light surface corrosion on a very small area (< 5%) - A reinforcement sample was taken out for optical emission spectroscopy analysis. After the reinforcement sample was taken out, the reinforcement area was reduced to approximately 20-30%. 	<p>3.9</p> <p>3.10</p> <p>3.11</p>

Break-up no. 4		
Location: Column no. 9, west side, see Figure 3.2		
Structural part	Description	Figure no.
Concrete	<p>The concrete was hard, but not sounding.</p> <p>Large honeycombs were located just above the break-up.</p>	<p>3.2</p> <p>3.7</p>
Reinforcement	<p>Vertical reinforcement (hairpin stirrup):</p> <ul style="list-style-type: none"> - Cover 0 mm (visible reinforcement) - Bar Ø30 mm - Serious laminated corrosion on reinforcement part with no cover (reinforcement area is reduced to approx. 40-50%) - 28 mm inside the concrete, there was no corrosion except for light surface corrosion on a limited area (< 20%) 	<p>3.12</p> <p>3.13</p>

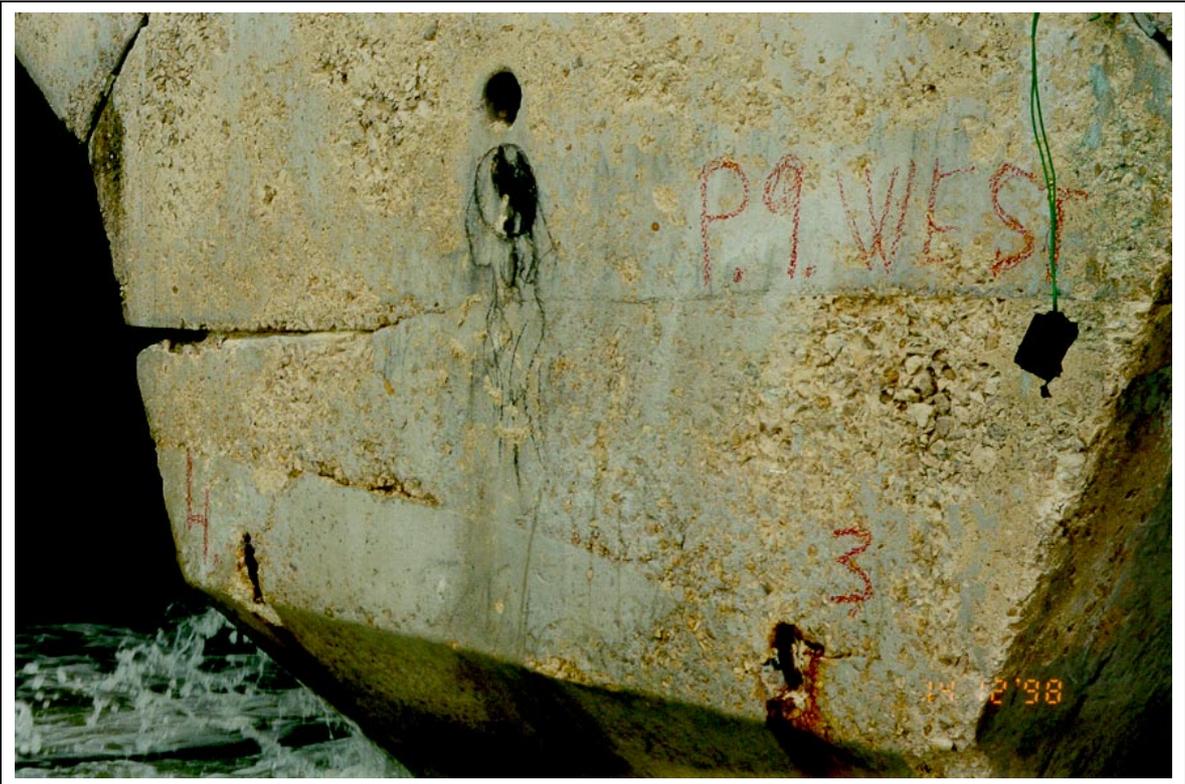
Figure 3.7 Concrete at the west side of column no. 9, break-up nos. 3 and 4

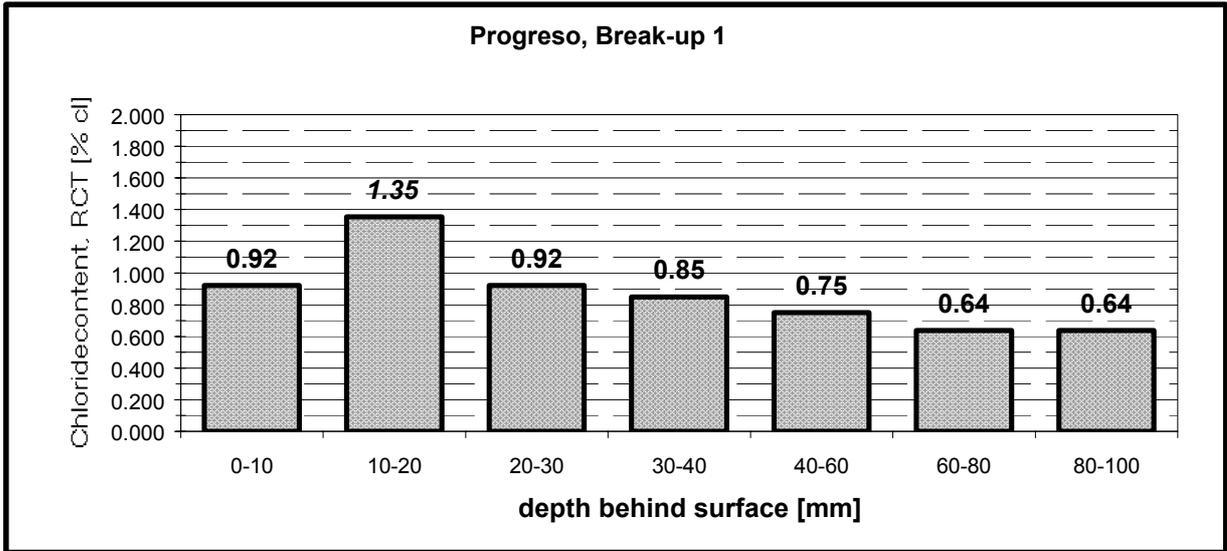
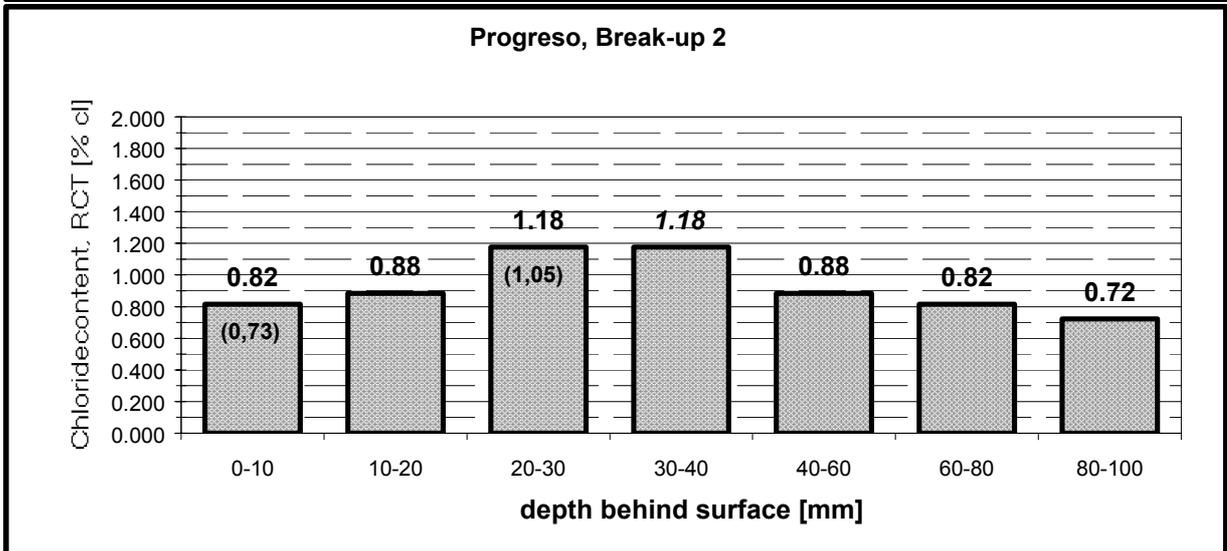
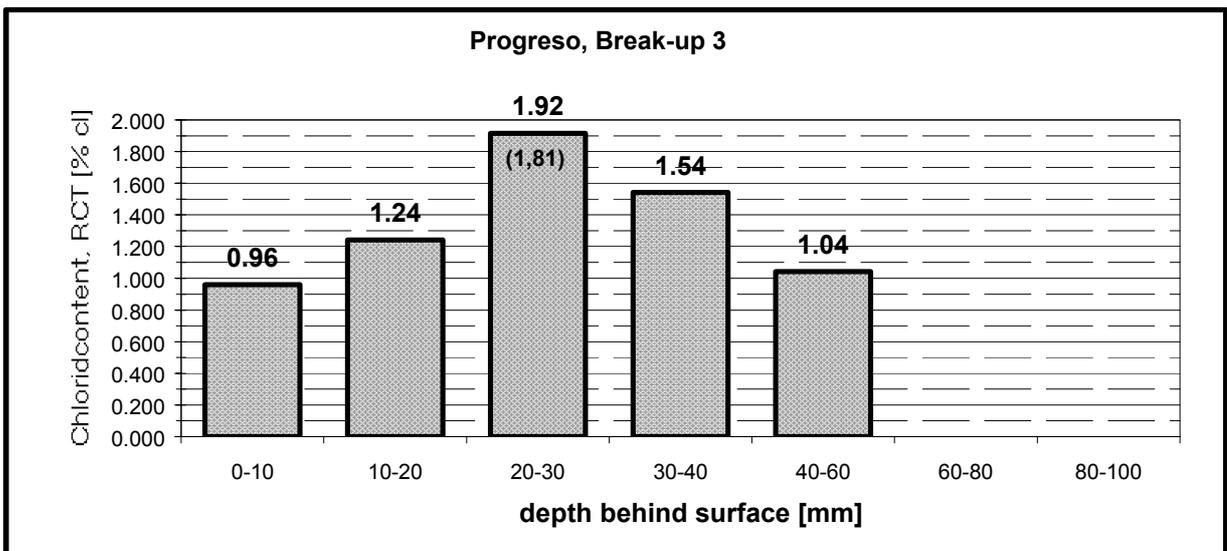
The graphs in this Appendix show the total acid soluble chloride content of the concrete (%Cl⁻ of dry concrete weight) as a function of the depth behind the surface. In the graphs the values determined by potentiometric titration are shown in brackets. For samples that became wet (seawater), the chloride content is written in *italic*.

Figure 4.1 Chloride measurements at break-up 1, 2 and 3

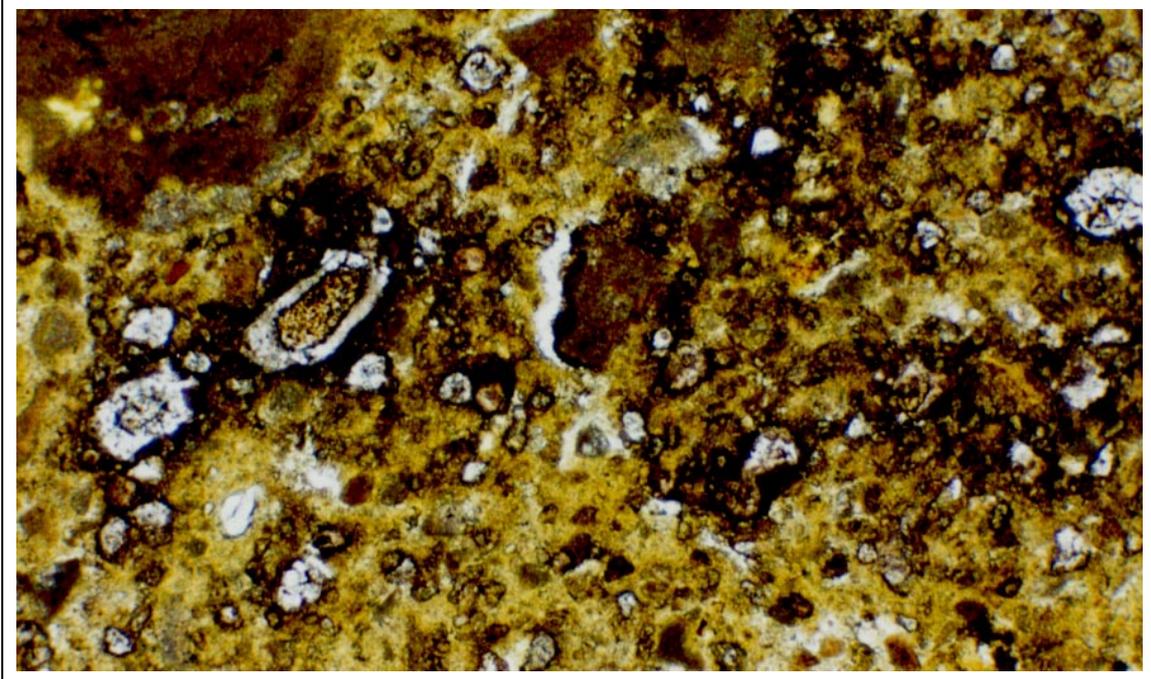
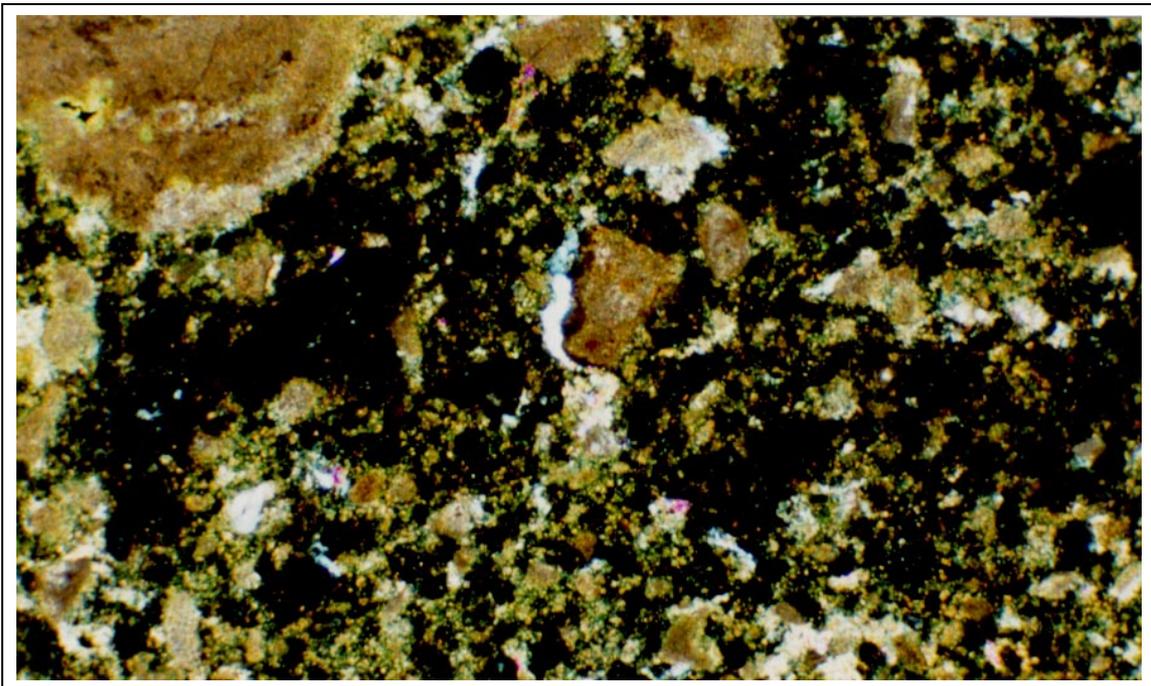
Sample No.: Column no. 9

Micrographs showing a typical area of paste with some unhydrated cement grains. The paste is partly carbonated (brownish on lower photo). The photos are taken in ordinary and crossed polarized light (same field of view), approx. 1.5 x 1 mm.
